# Flood Risk Study - Church Lane, Etchingham

East Sussex County Council has been notified by local residents of Etchingham that there is a flooding problem on Church Lane. This technical note aims to clarify the current position and to investigate the key flooding mechanisms and possible options to manage the existing flood risk.

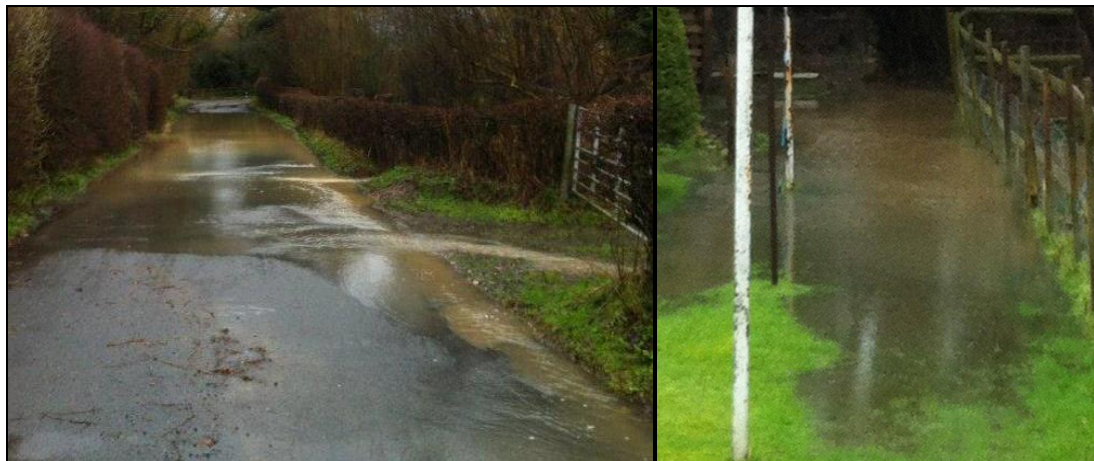
**Figure 4 – Photos of Flooding from Jan 2012 Event**

There have been numerous flood events which have impacted on the residents of Church Lane with the most recent occurring on 3<sup>rd</sup> January 2012.

Typically flooding has occurred after a prolonged period of intense rainfall causing flooding to the Church Lane highway and curtilage flooding of properties.

The flooding experienced on Church Lane appears to be a combination of surface water and ground water flooding.

The surface water runoff from the elevated fields situated to the south west of the properties at risk is caused by a combination of the relatively high topographic levels, the Wadhurst Clay, low vegetation within the field to intercept flows and the local farmer ploughing downhill encouraging the conveyance of flows in a north-easterly direction towards Church Lane.

The ground water flood risk is confirmed by the residents observing the cartilage of the properties is frequently boggy with poor drainage. The geological map indicates Church Lane is situated on the border of clay and sand which typically indicates the possibility of localised springs appearing during prolonged period of rainfall. This is confirmed by the screenshots in Appendix A which has been taken from Google Streetview showing the egress of groundwater flows by a telegraph pole which then flows down Church Lane to the properties at risk before entering a local highway drain. This groundwater reduces the capacity of the existing 150mm dia sewer to accept flows during a rainfall event.

The properties at risk are located in a low-spot with a railway line embankment situated to the north limiting the conveyance of flows from Church Lane to the River Rother.

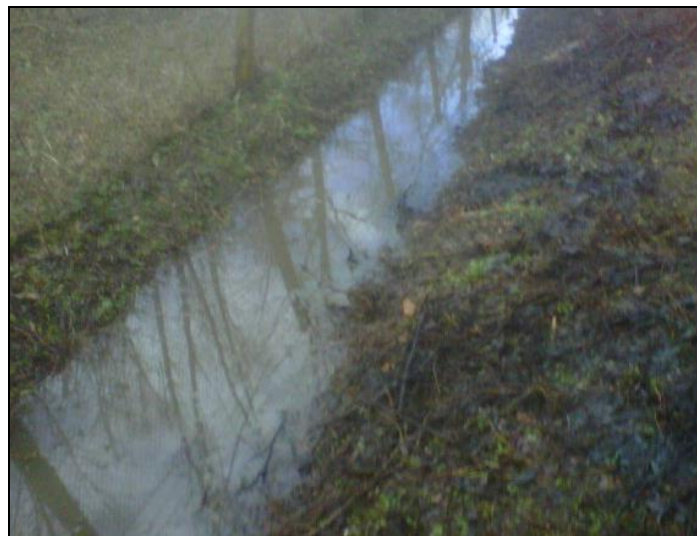
**Figure 5 – Photo of ditch clearance**

Through consultation with the partners in the summer of 2011 it was agreed the Railway line ditch situated to the rear of the properties requires vegetation clearance to improve the conveyance of the channel; this was undertaken by Network Rail in November 2011.

Since the ditch clearance has been undertaken local residents have recorded another flooding event in January 2012 which resulted in highway and curtilage flooding.

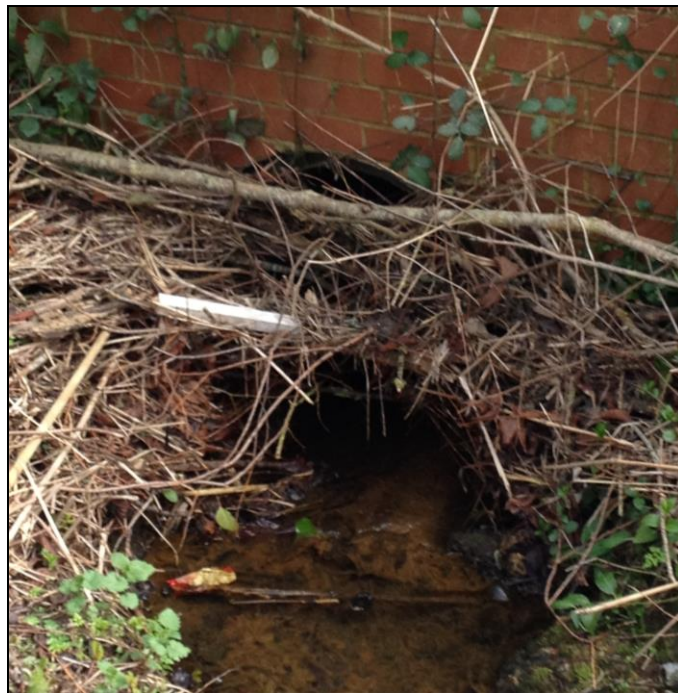
**Figure 6 – Photo of debris build up against culvert**

- The upstream face of the culvert running under the Station Approach (Culvert C in Figure 7) is partially blocked with debris (see Figure 6 below).

- Current riparian landowners of the drainage ditch on Church Lane are required to clear the watercourse to an acceptable standard to improve conveyance.
- Network Rail is required to clear and widen the watercourse within their land to improve conveyance.
- Network Rail is required to remove the chainlink fence which is currently acting as an obstruction in the watercourse and replace with a trash screen.

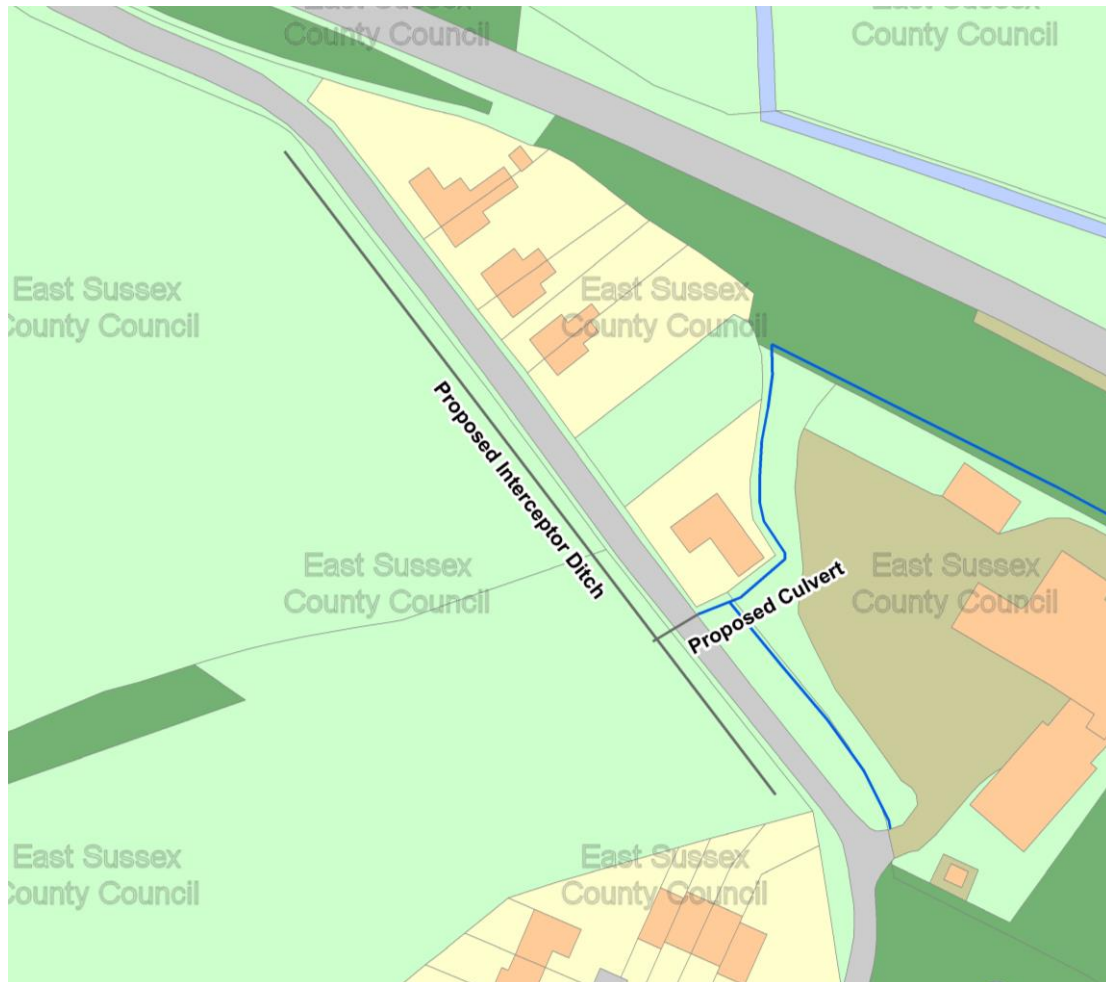
Figure 8 – Proposed Flood Alleviation Scheme

The immediate actions will reduce flood risk, however it will not resolve the associated flood risk experienced across Church Lane.

- Installation of interceptor drainage ditches within the fields
- Installation of culvert under the highway accepting flows from the interceptor ditch to discharge into the existing channel running alongside the property on Church Lane.
