Hydroecological Assessment

Breadsell Farm, Hastings
Wates Developments

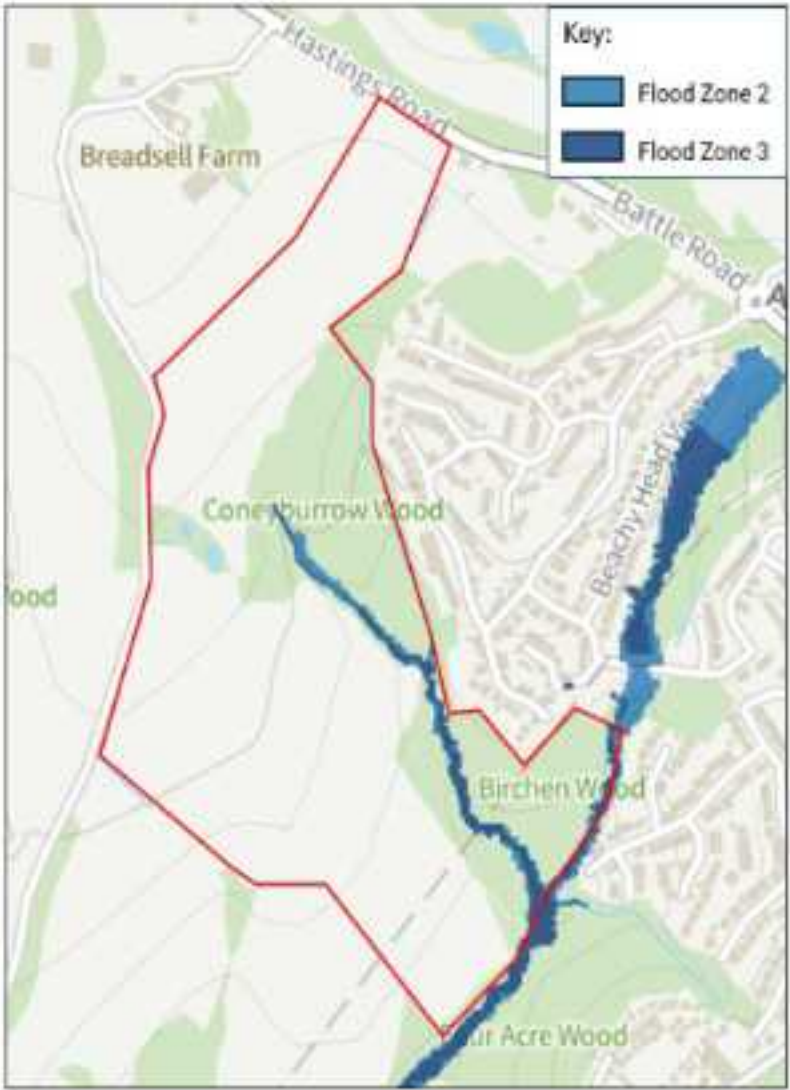
Figure 4-3. EA Flood Map for Planning.

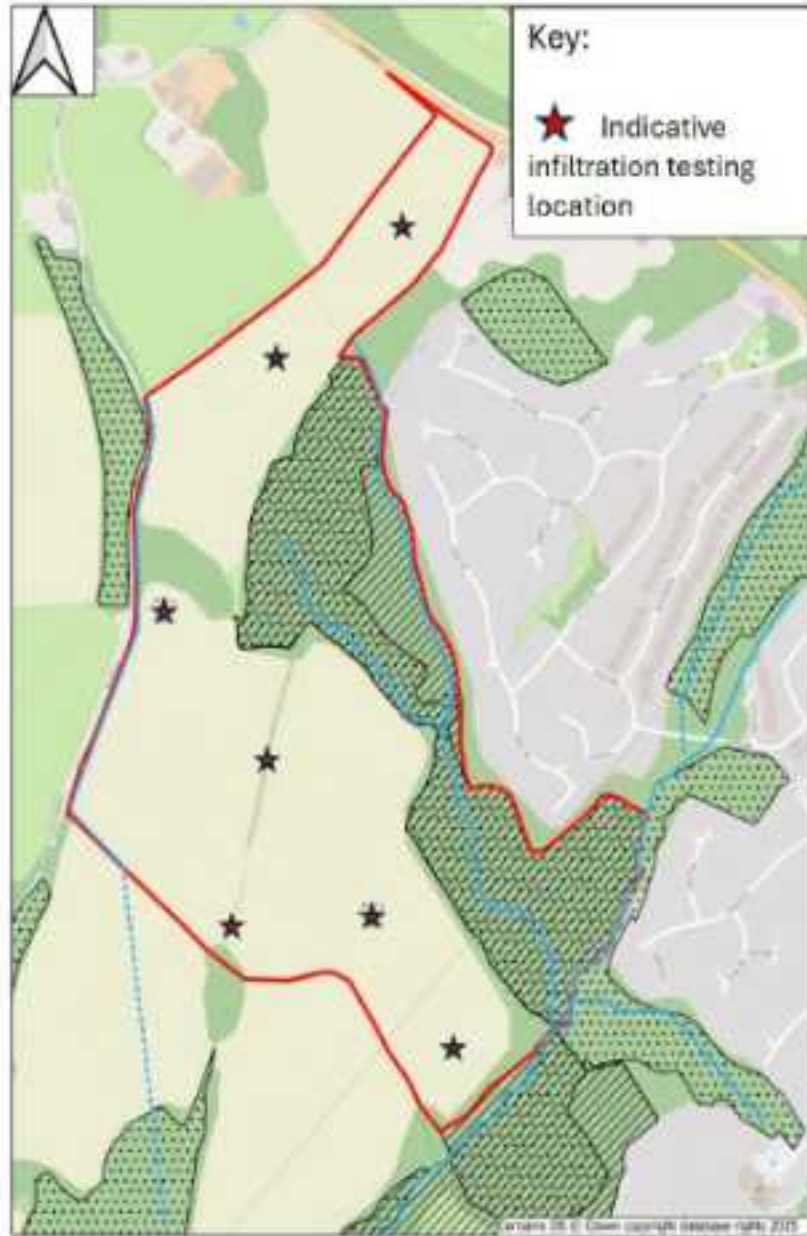
Figure 8-1. Proposed infiltration testing locations.

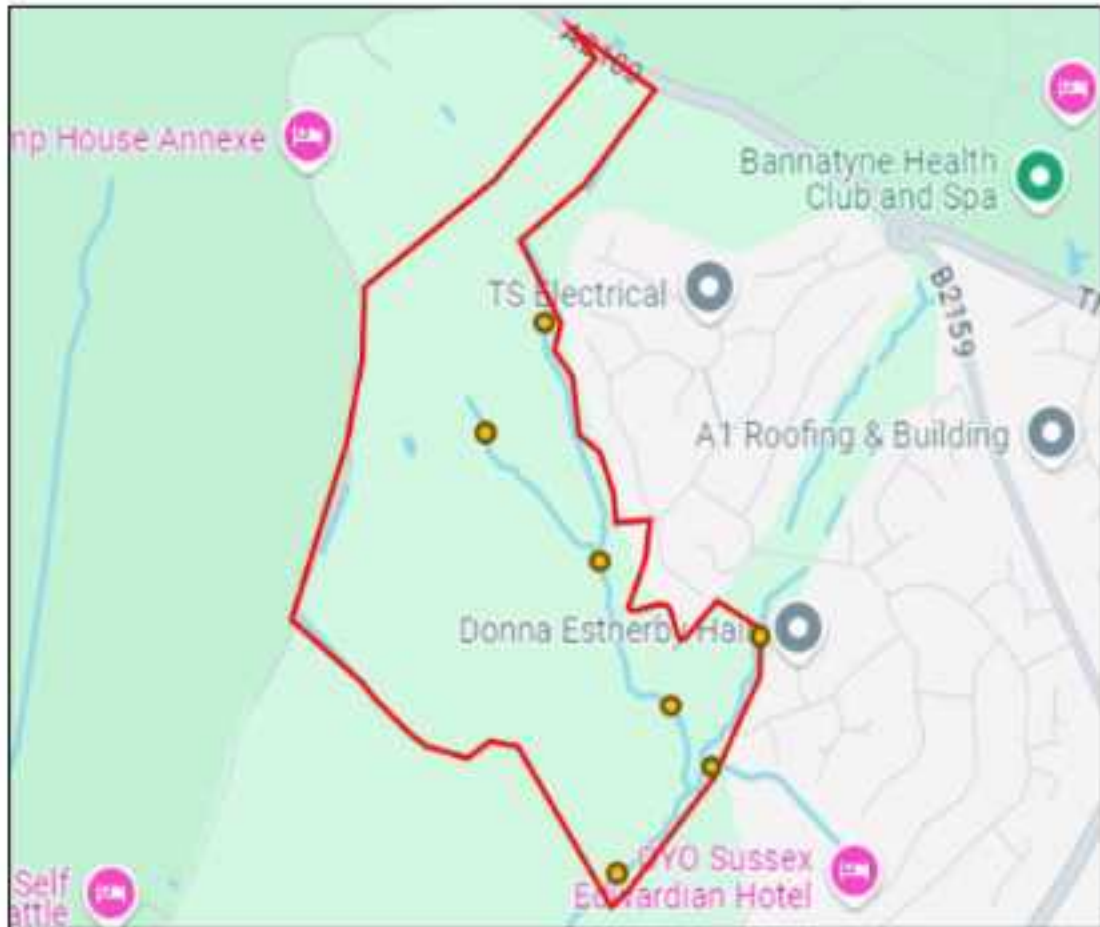
Figure 8-2. Proposed surface water quality/flow monitoring locations.

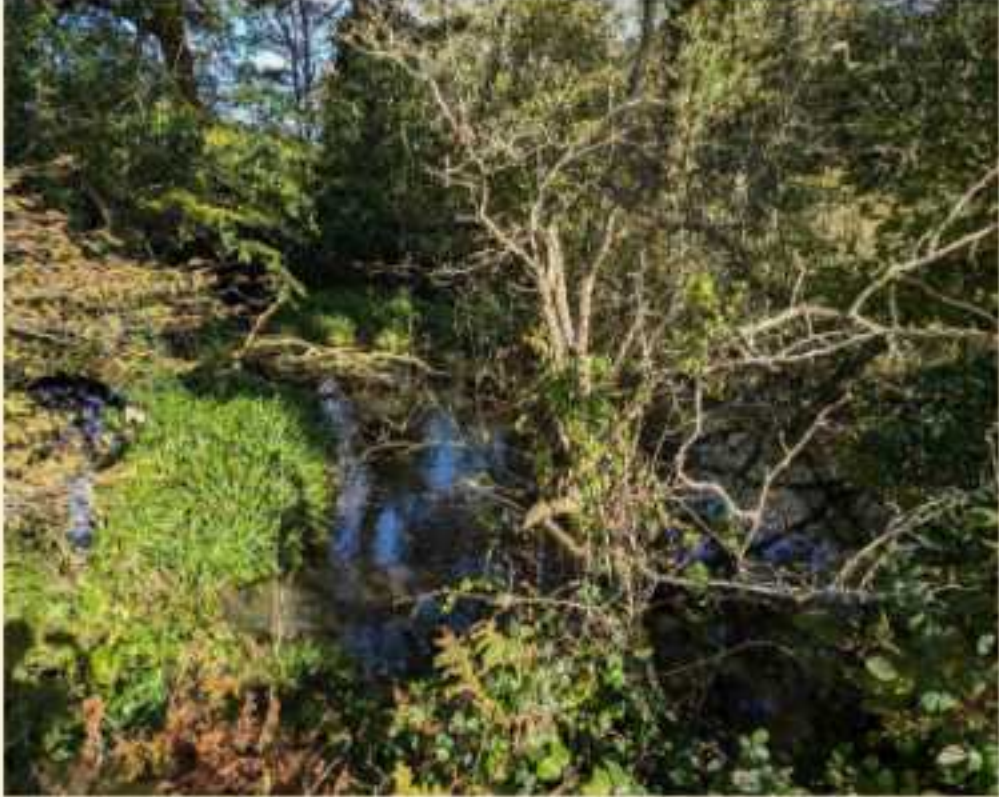
<p>Pond observed within woodland between the northern and southern fields.</p>

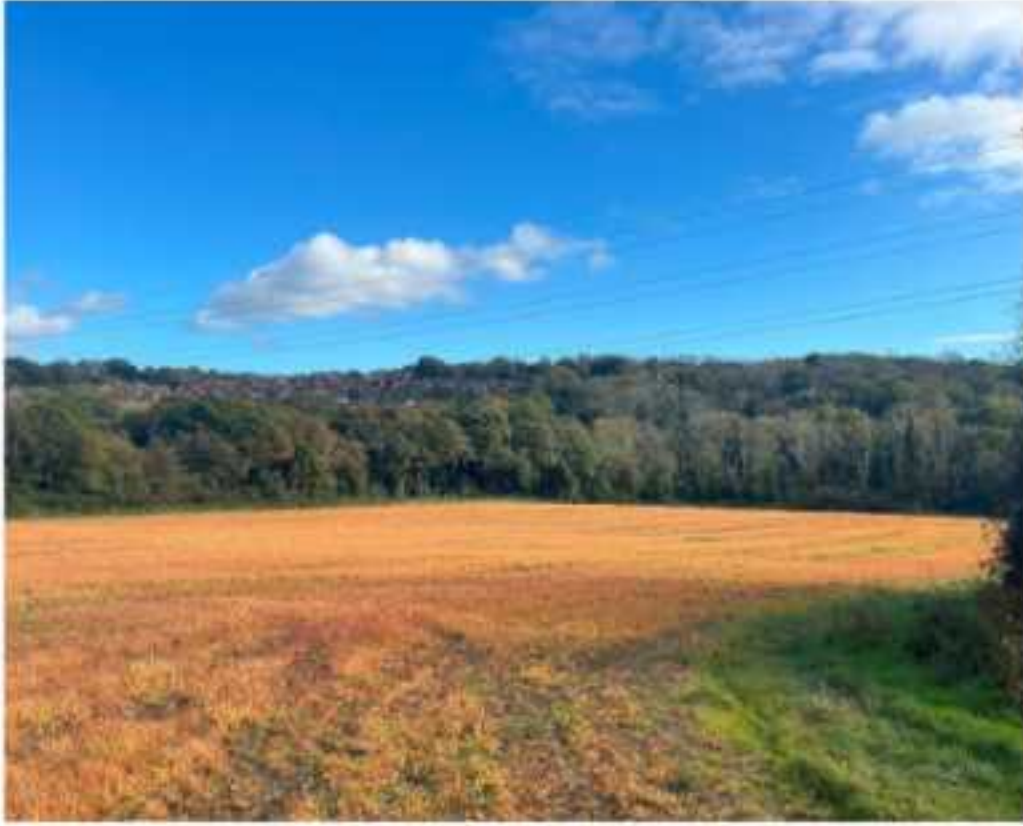
View across the field in the south eastern part of the site, looking towards the south east.

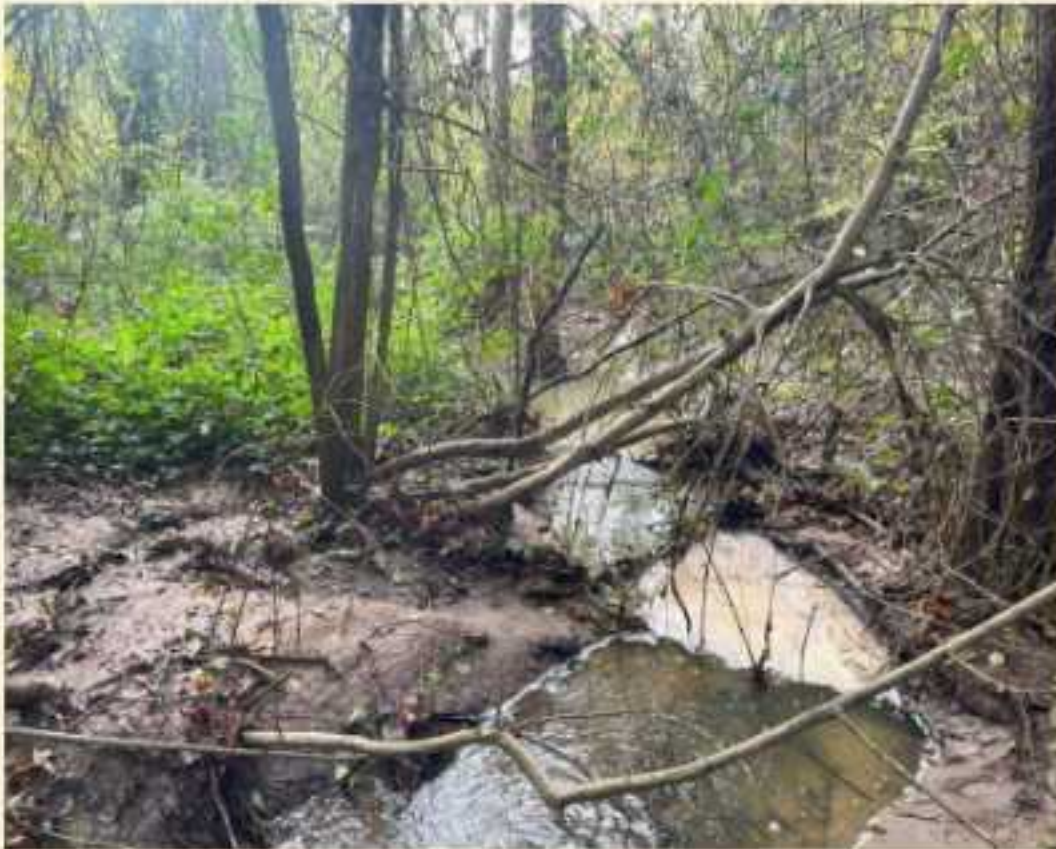
Scum observed on the water surface of the Marline Valley Brook.

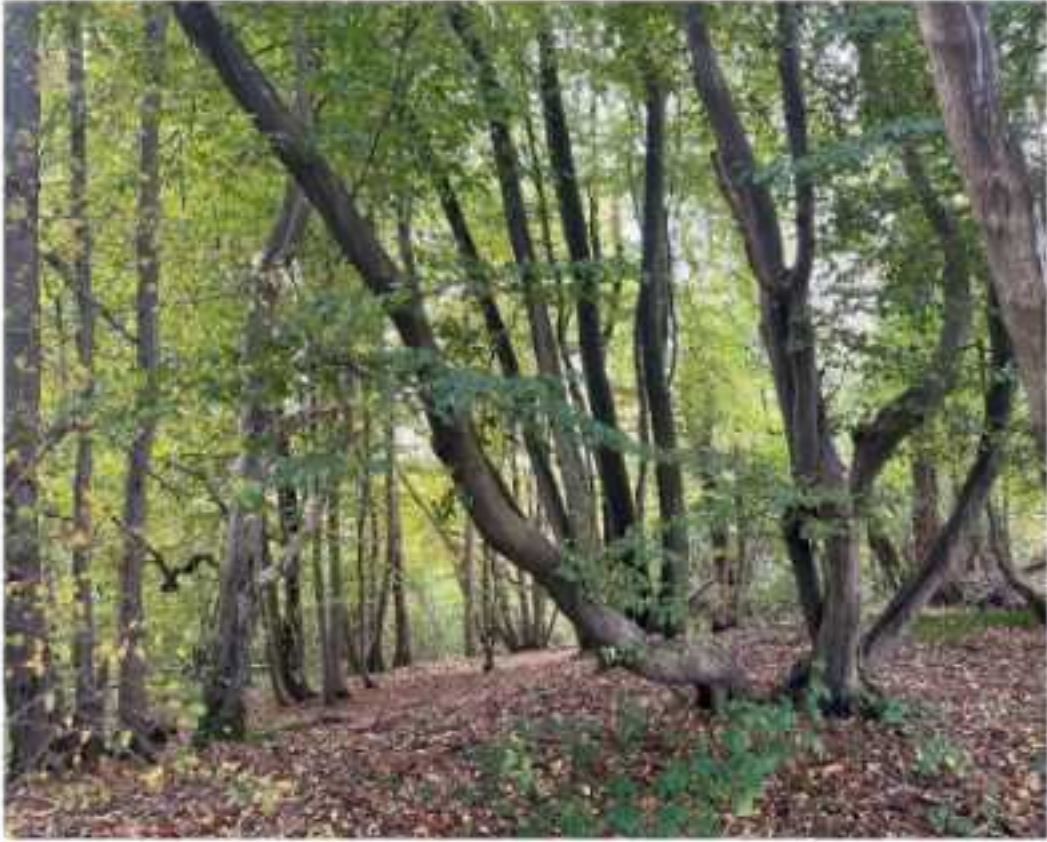
Marline Valley Woods SSSI, located in the eastern part of the site.

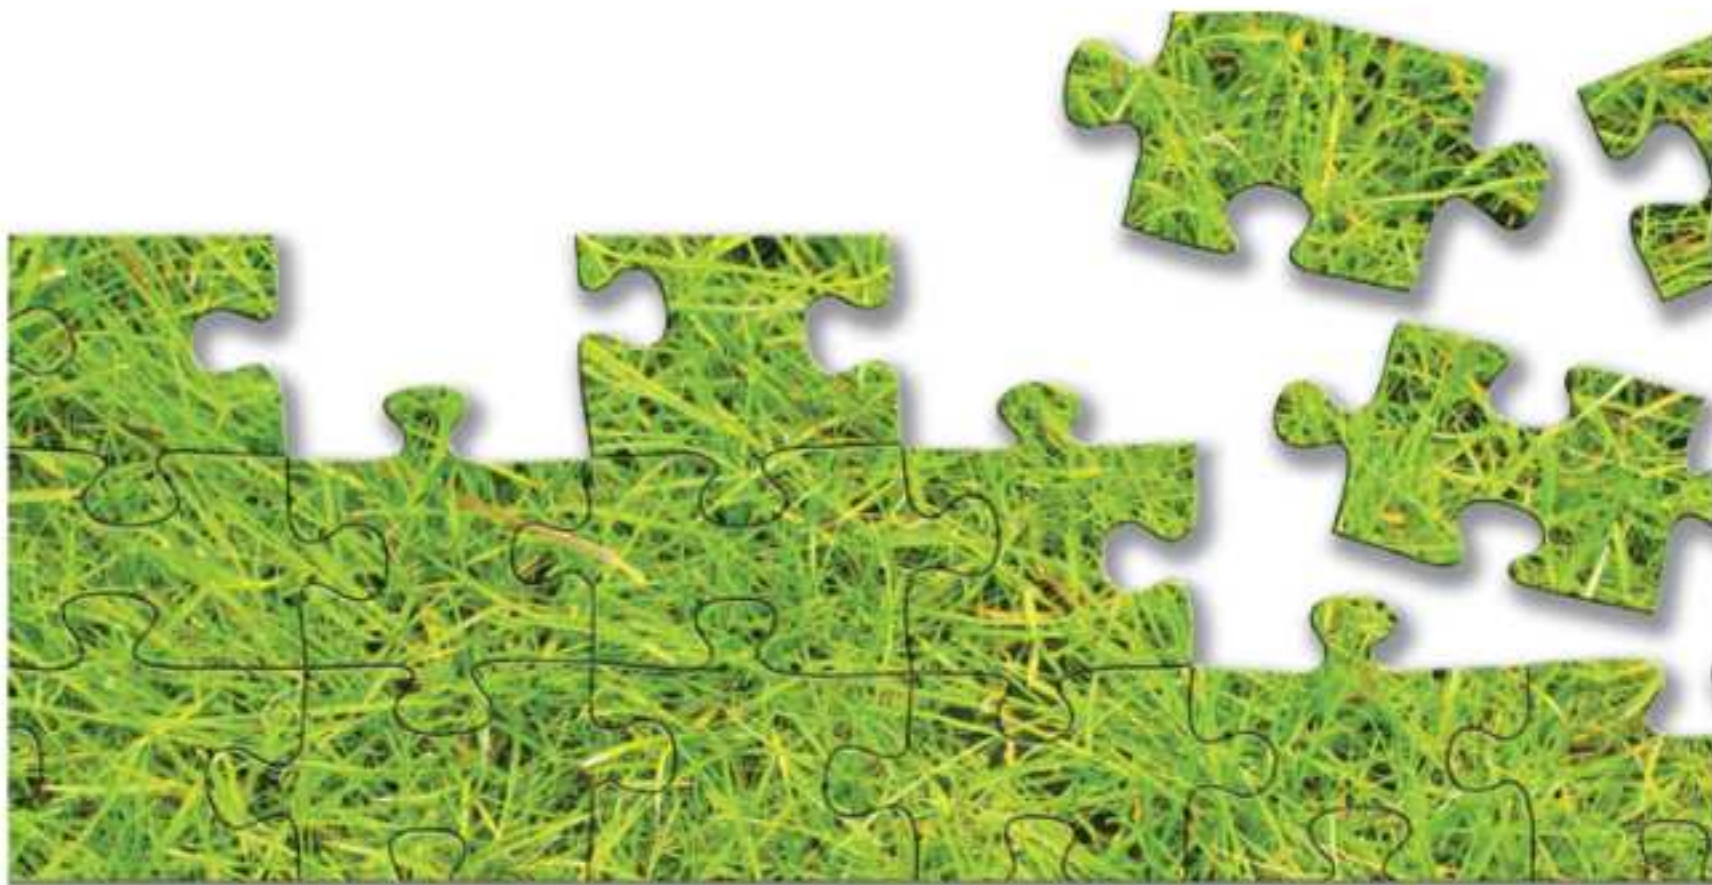
VEGETATION SURVEY & ASSESSMENT

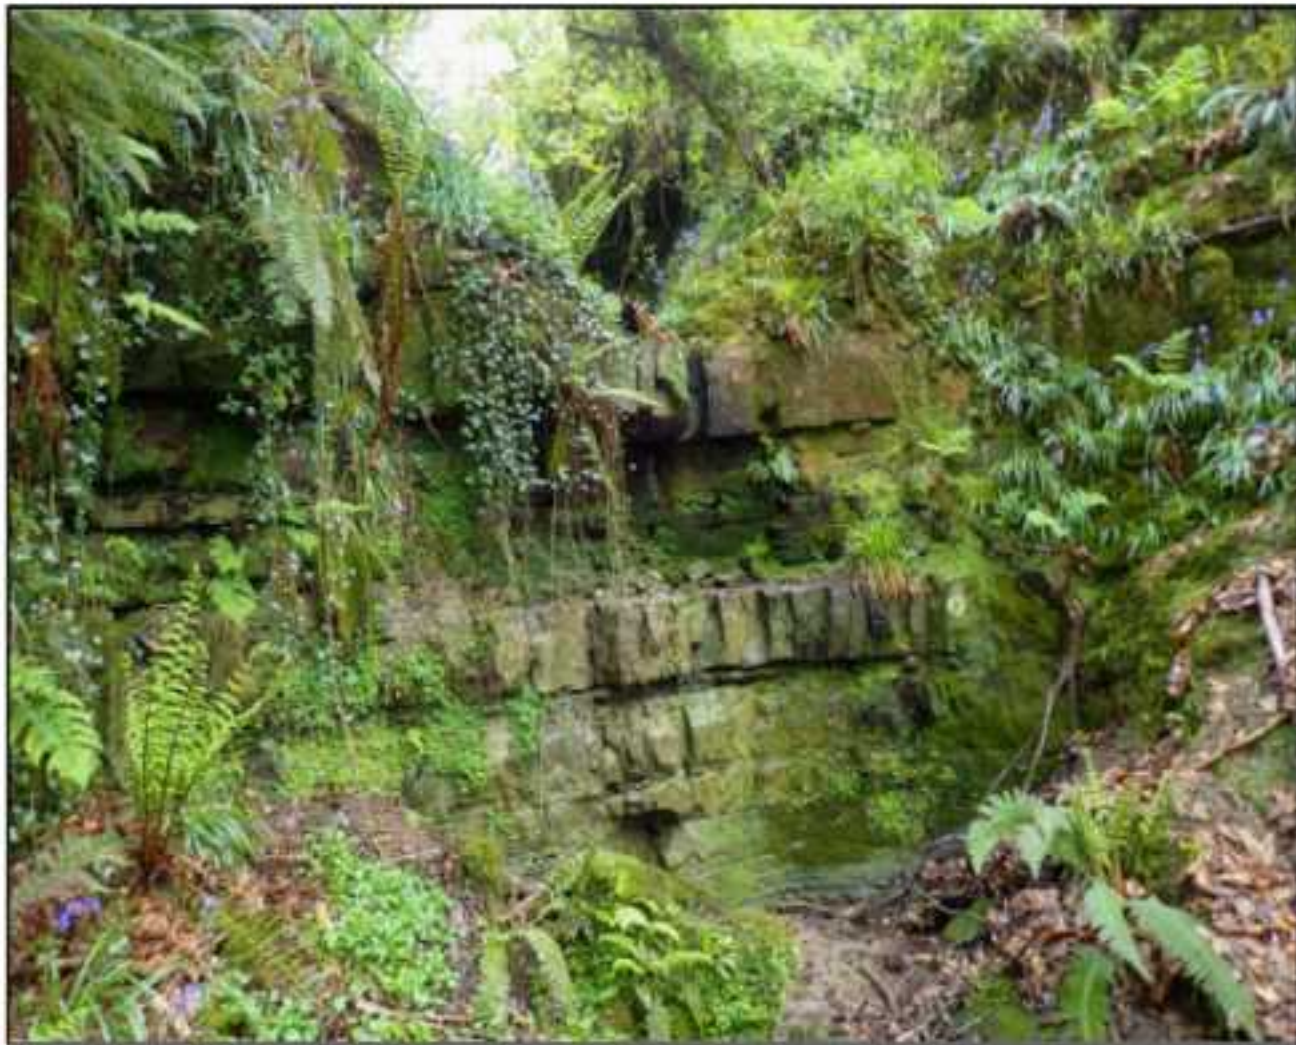
Plate 1. Waterfall in Coneyburrow Wood (OS gridref TQ7810813228). *Tetradontium brownianum* occupies one side of the rocky gully immediately above the waterfall and *Fissidens rivularis* is abundant on its damp face.

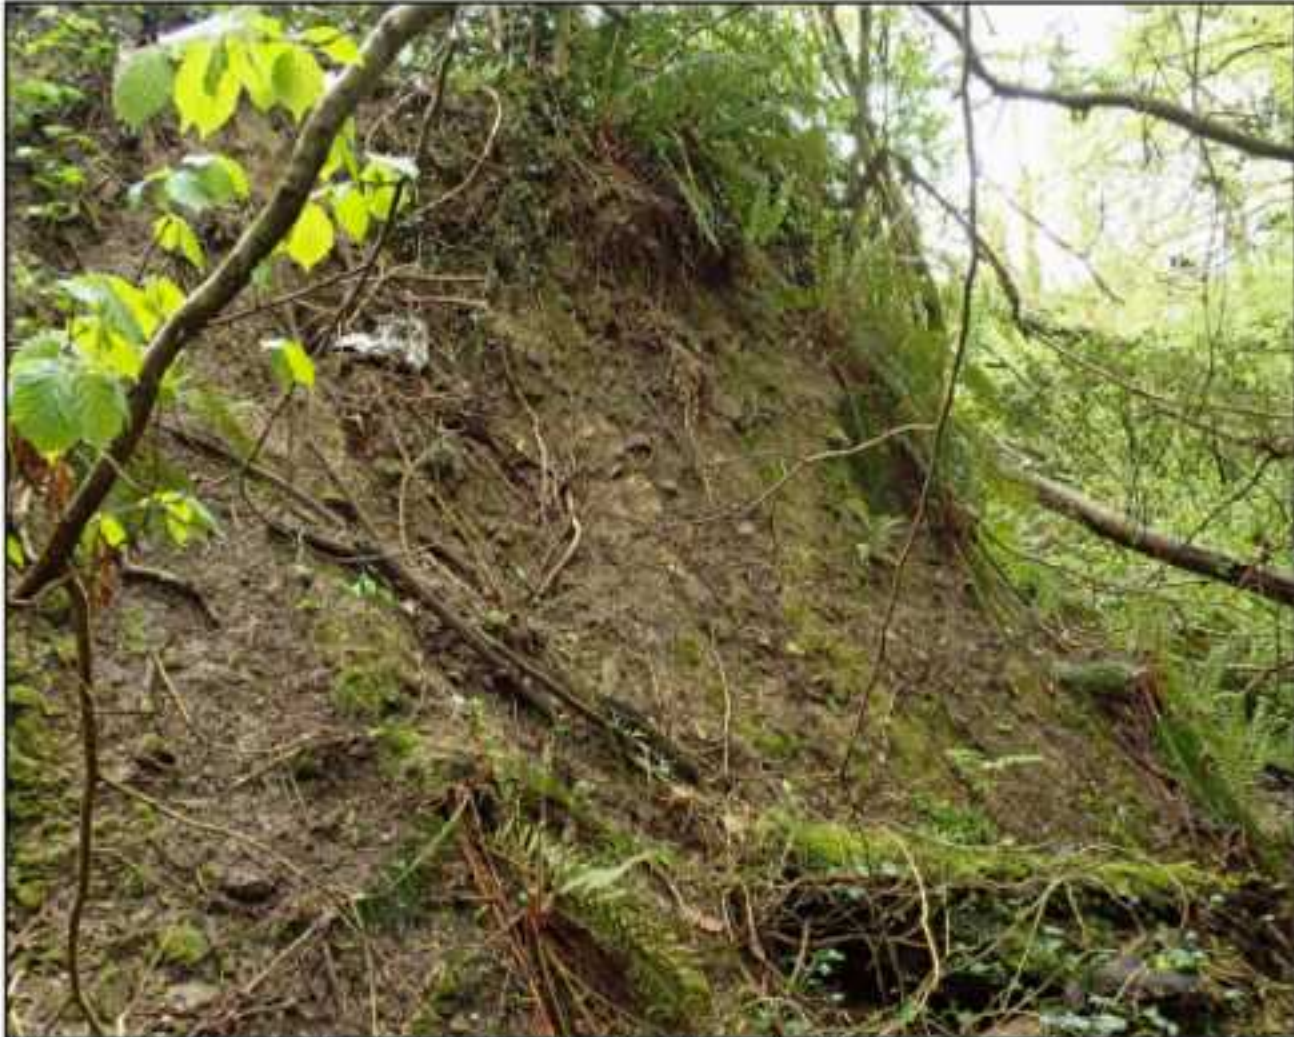
Plate 2. A substantial recent stream bank collapse in Coneyburrow Wood.
