# Flood Risk Study - Church Lane, Etchingham

East Sussex County Council has been notified by local residents of Etchingham that there is a flooding problem on Church Lane. This technical note aims to clarify the current position and to investigate the key flooding mechanisms and possible options to manage the existing flood risk.

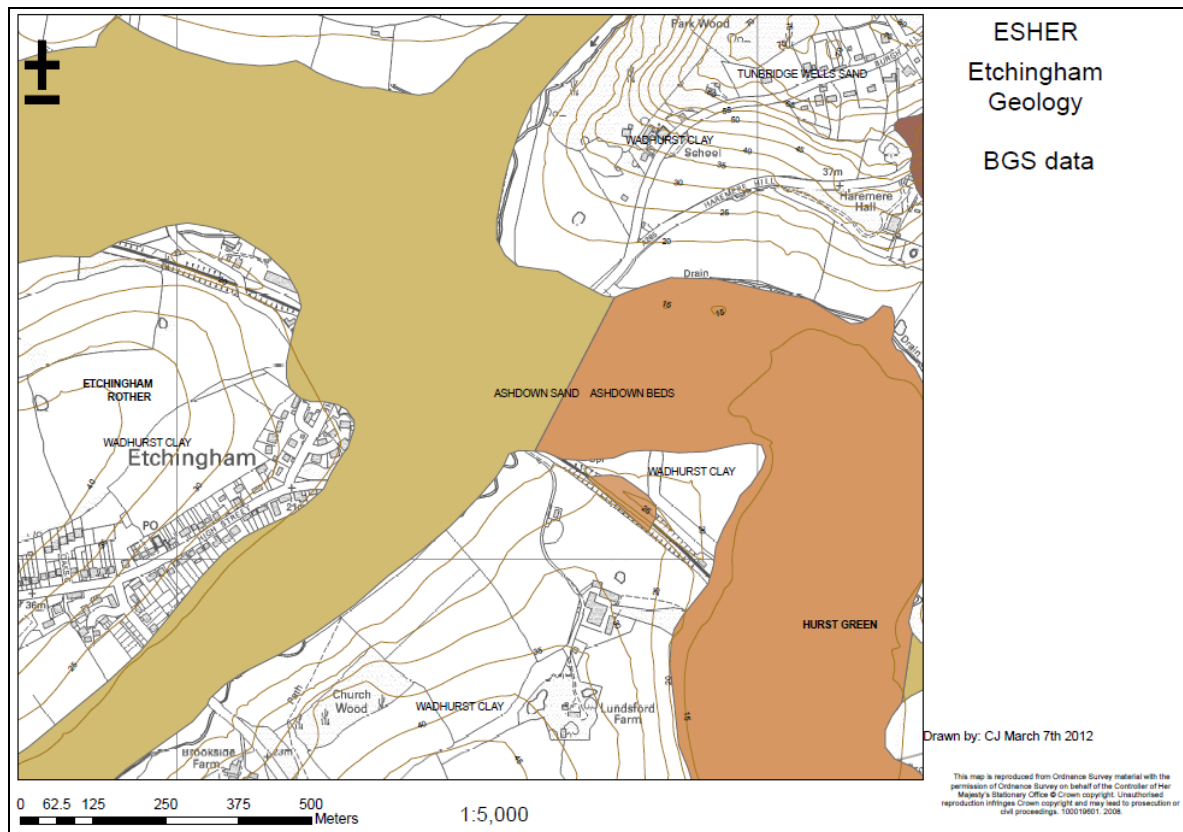
**Figure 2 – Geology Plan**

The geology of the high ground situated immediately to the southwest of Church Lane comprises of Wadhurst Clay with the properties on Church Lane being located on Ashdown Sand (see Figure 2 below).

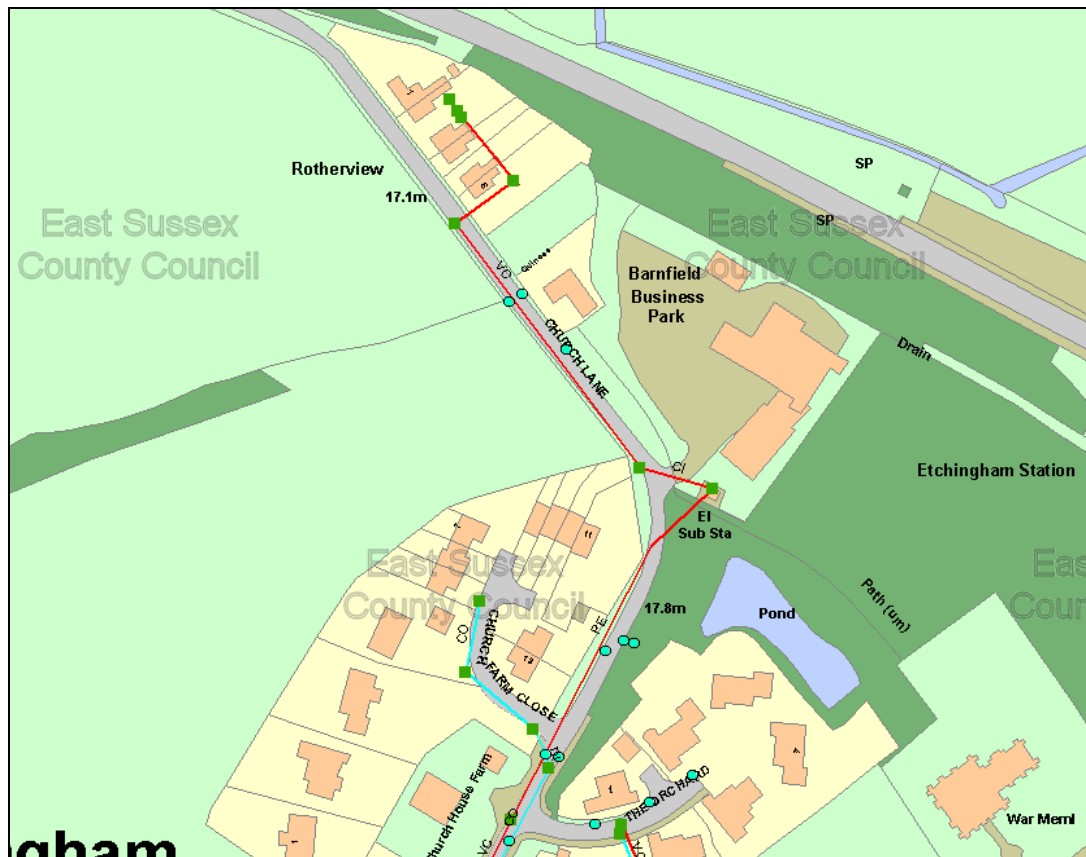
**Figure 3 – Existing Southern Water Drainage Arrangements**

Southern Water's existing drainage arrangements comprise of a 150mm dia combined sewer running along Church Lane draining in a south-easterly direction (highlighted in Figure 3 in red). Three ESCC highway gullies are located along the stretch of Church Lane which is most at risk of flooding, which is assumed to discharge into Southern Water's 150mm dia pipe.
