Representations in respect of the Regulation 18 Rother Local Plan

(Q67)- Comments SHELAA assessment – site PEA-0039 (Pond Cottage and adj land)

**HISTORIC BUILDING
ASSESSMENT**

**In relation to proposed detached 10 no
retirement flats.**

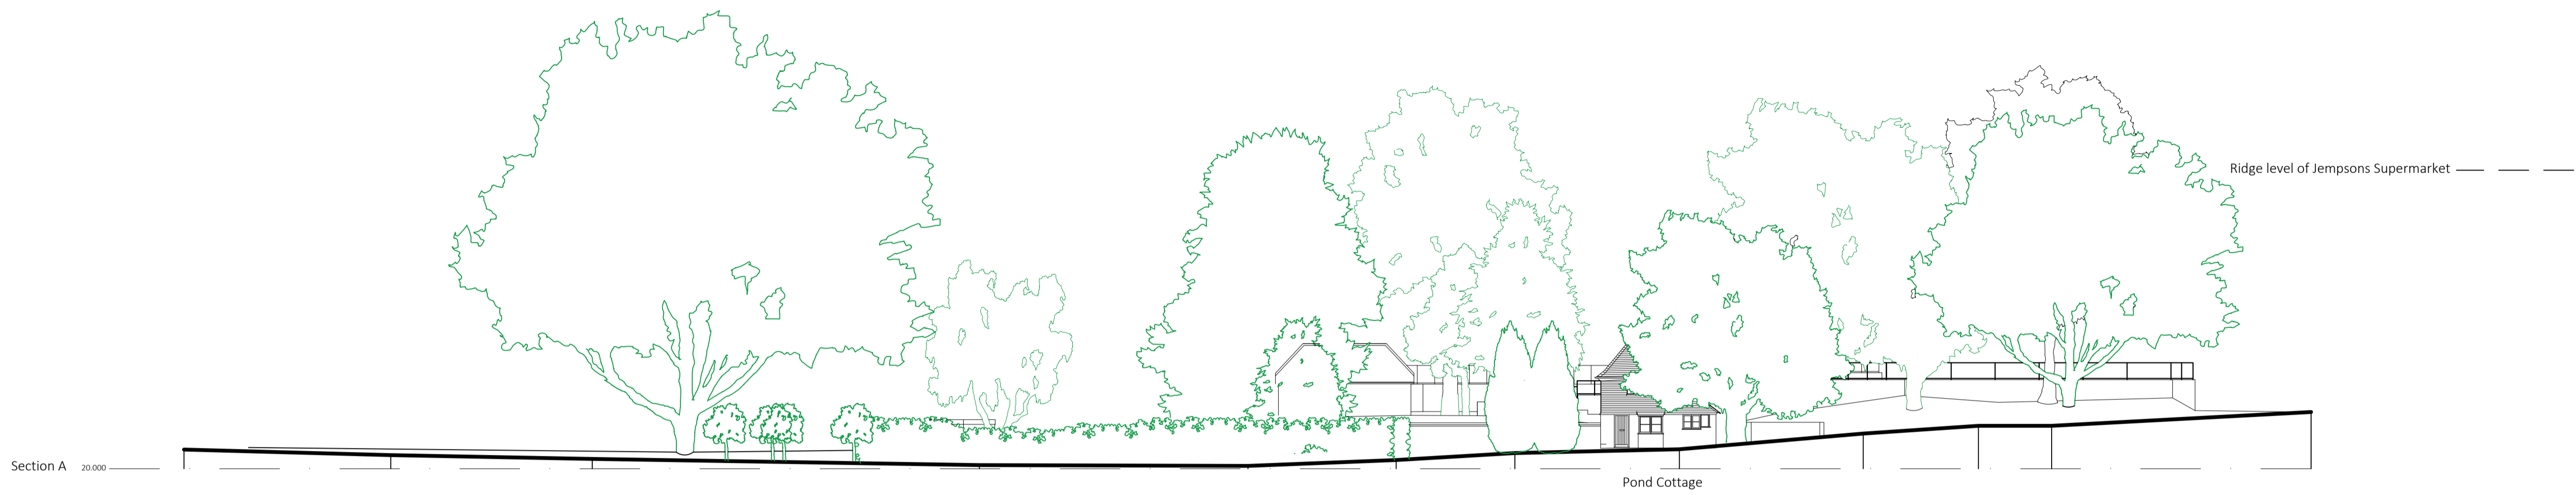
As Existing Site Section

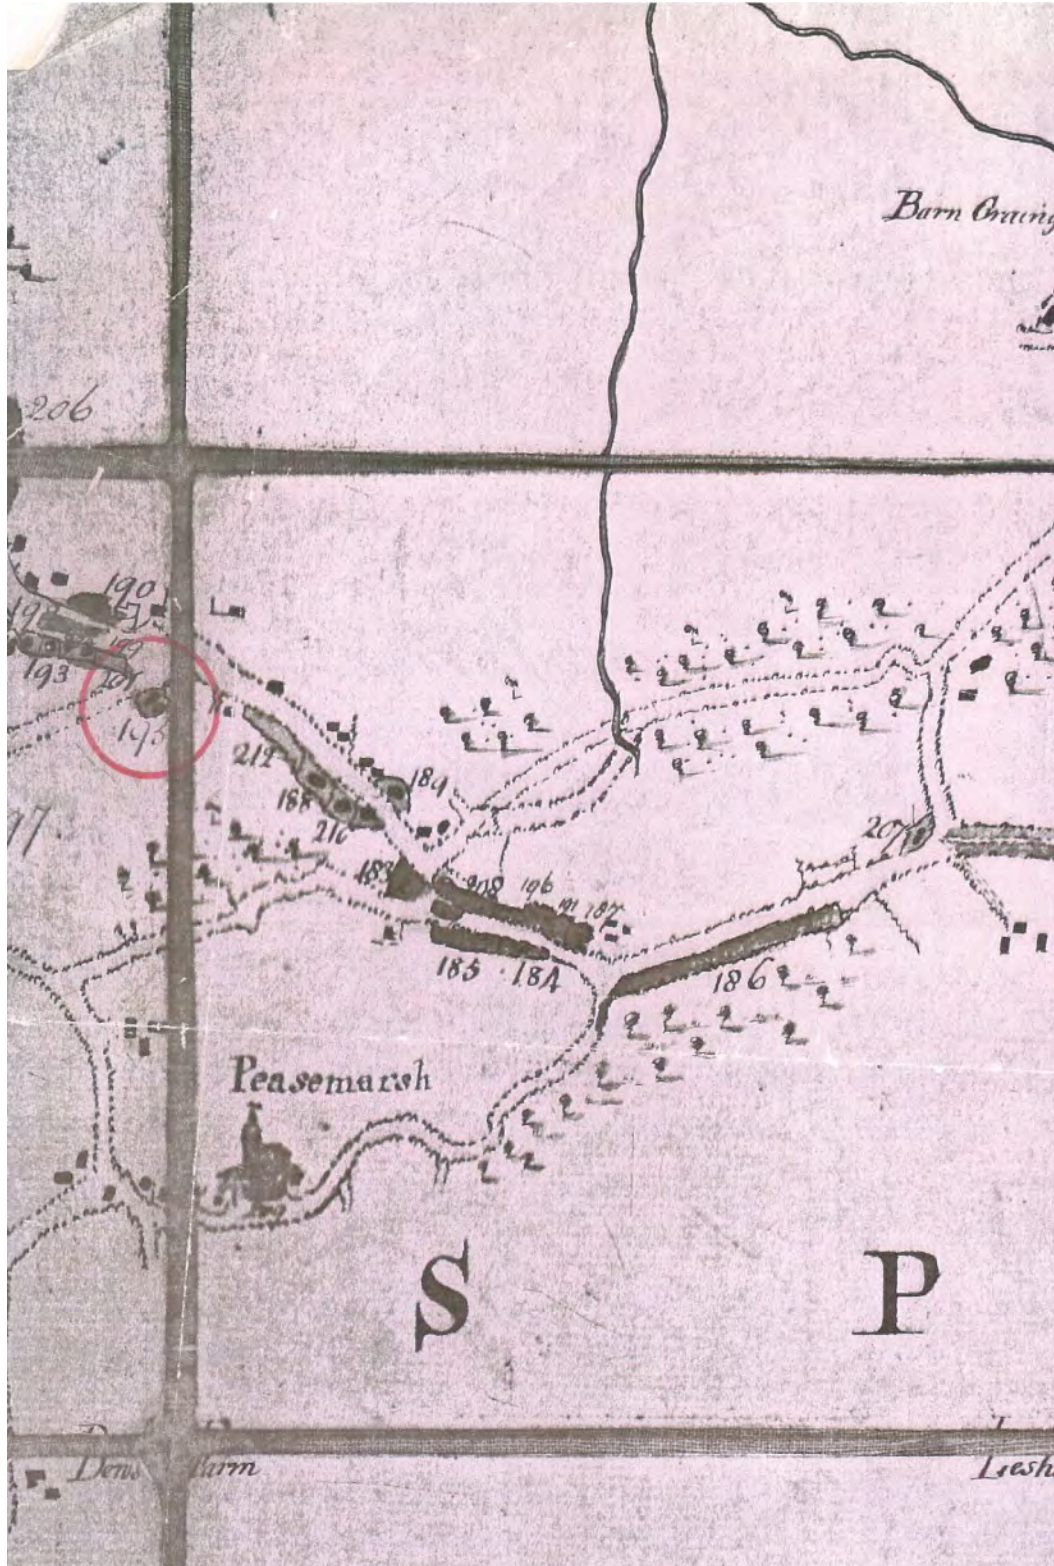
Map of roadside waste land 1788

The site of Pond Cottage was originally part of the highway at the junction of Main Street and Tanhouse Lane. Main Street was originally wider, in particular, to the west at the approach uphill to Flackley Ash. An island of development remains within the road edges, and this was needed to cope with muddy conditions, particularly on hills.

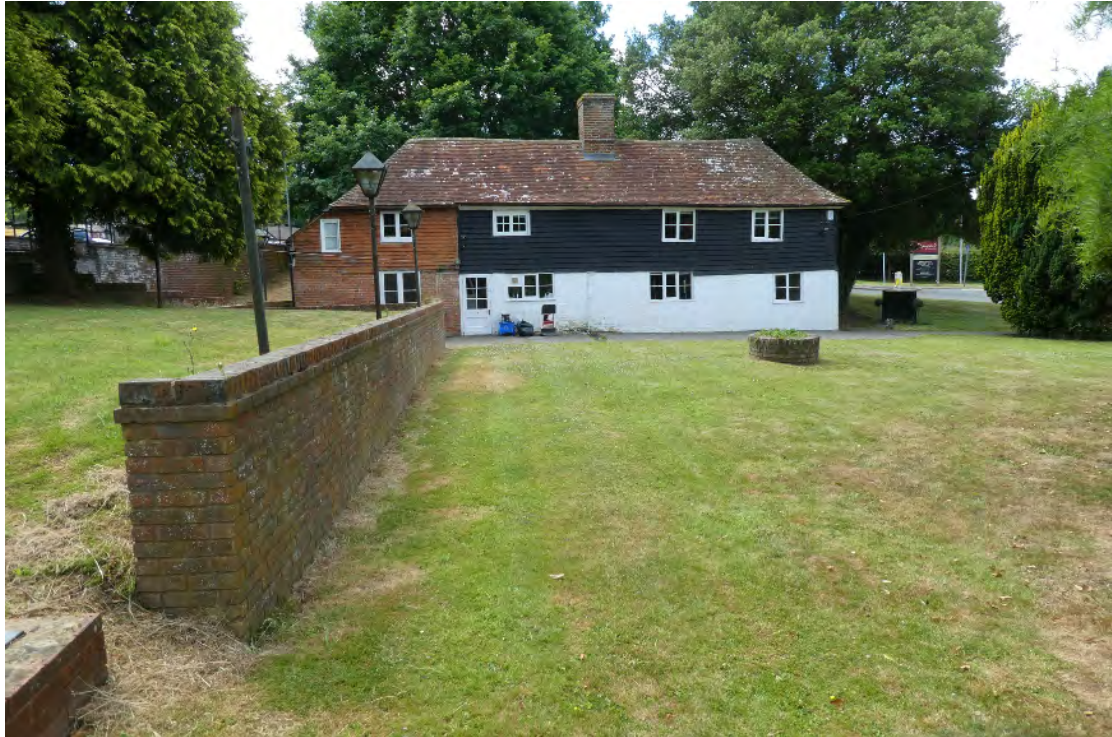
1. Front (north), phase 3 extension left.

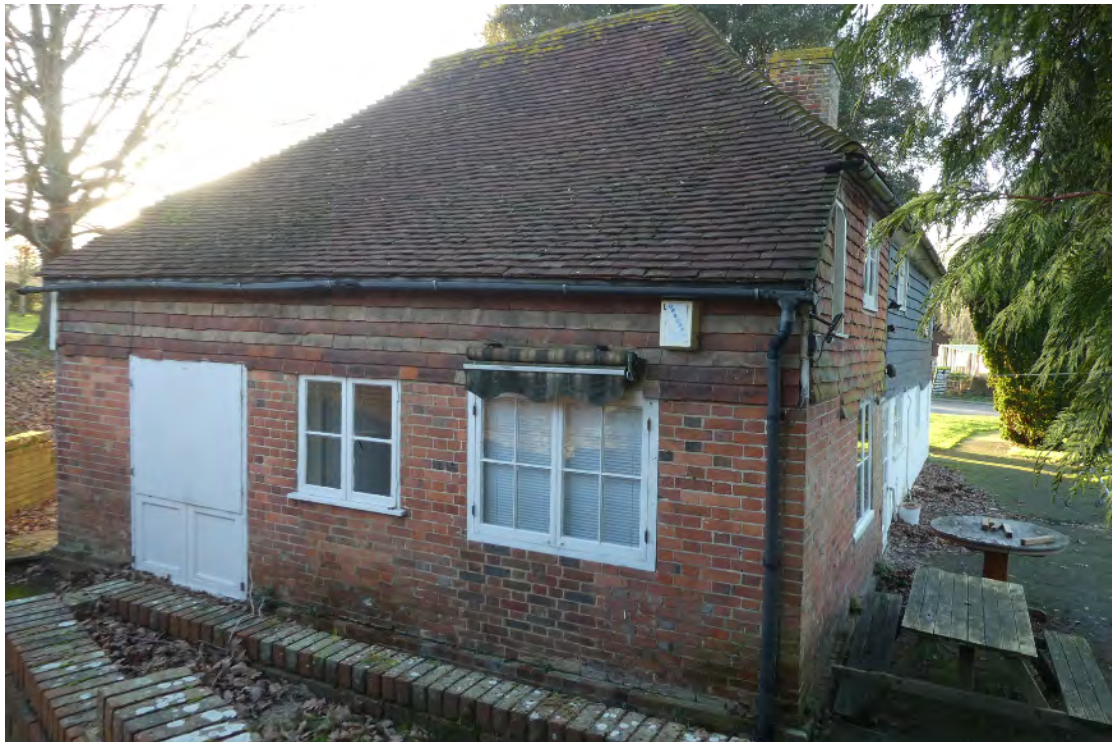
2. Side (east) showing phase 3 extension.

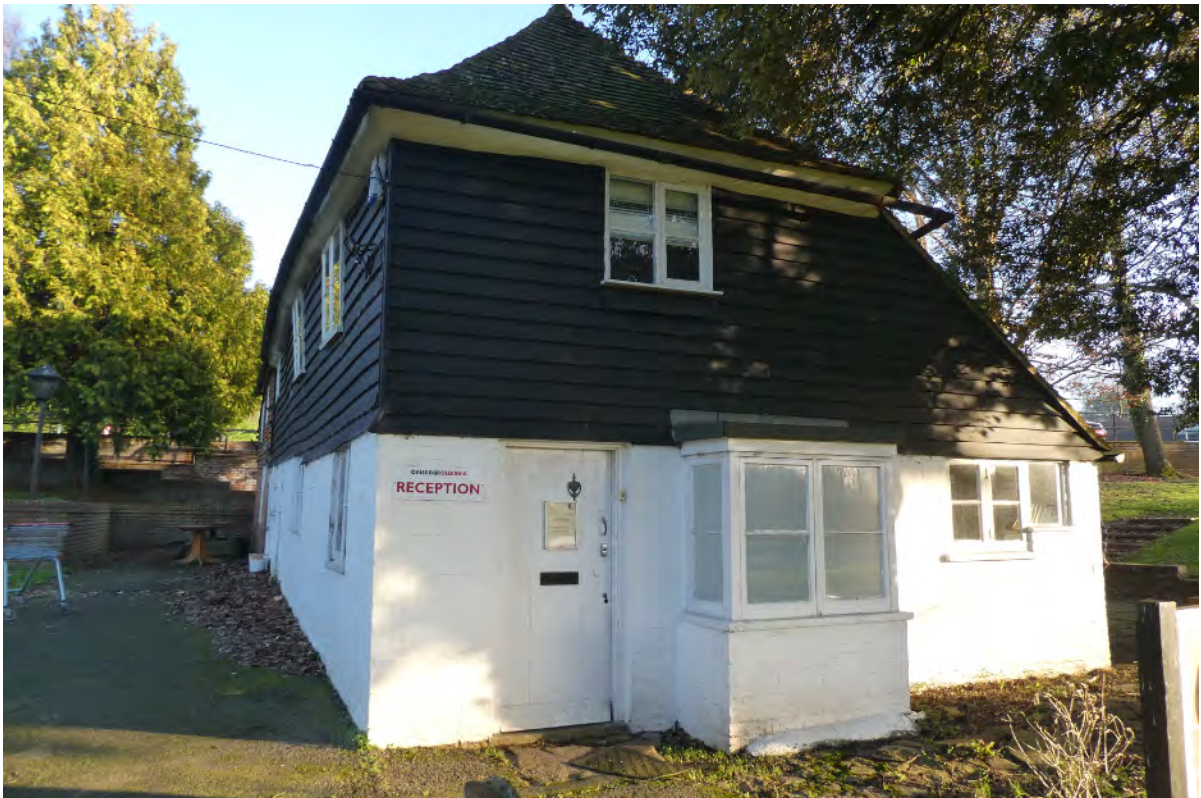
4. Side (west) showing phase 2 west extension.

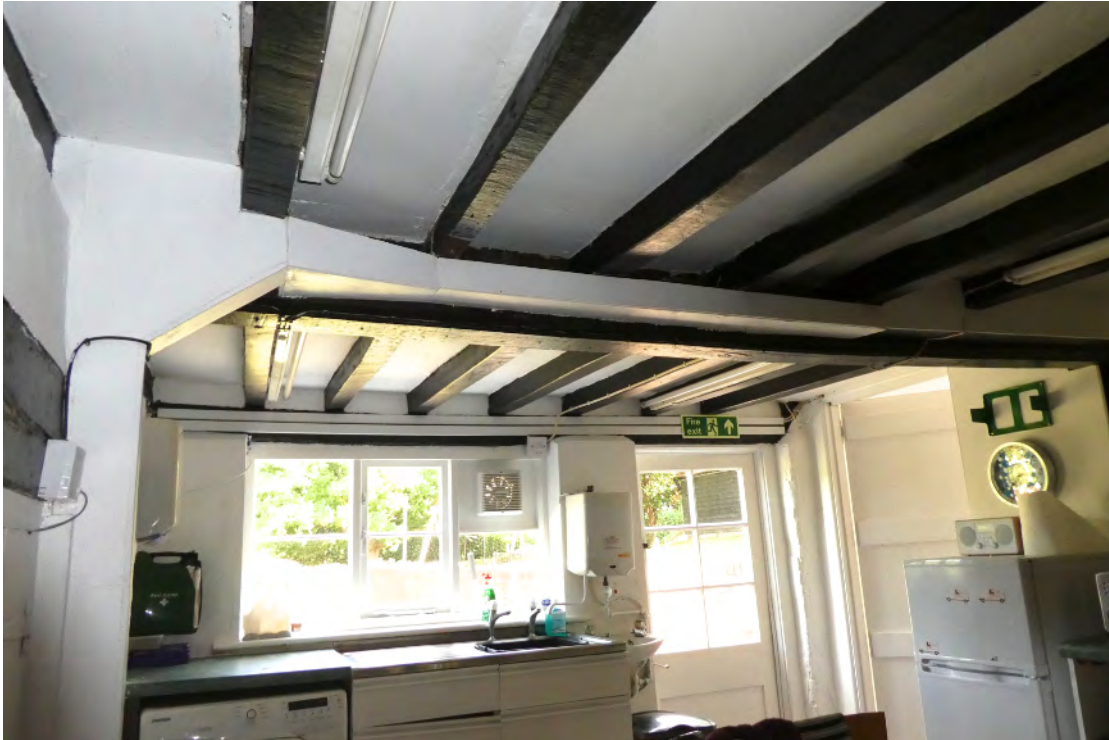
5. Phase 1 services room (present kitchen) looking north showing first floor central girder construction.

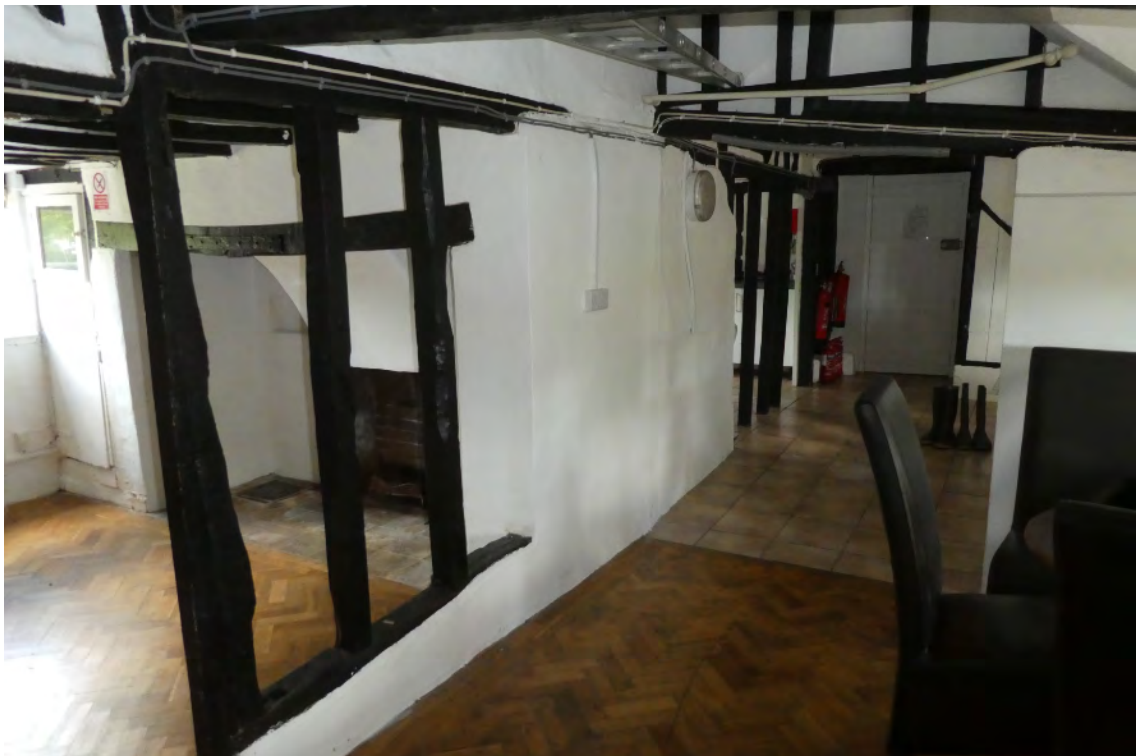
6. Interior of rear leanto looking east showing rear wall of phase 1 main frame, west end post left and intruded phase 2 chimney centre.

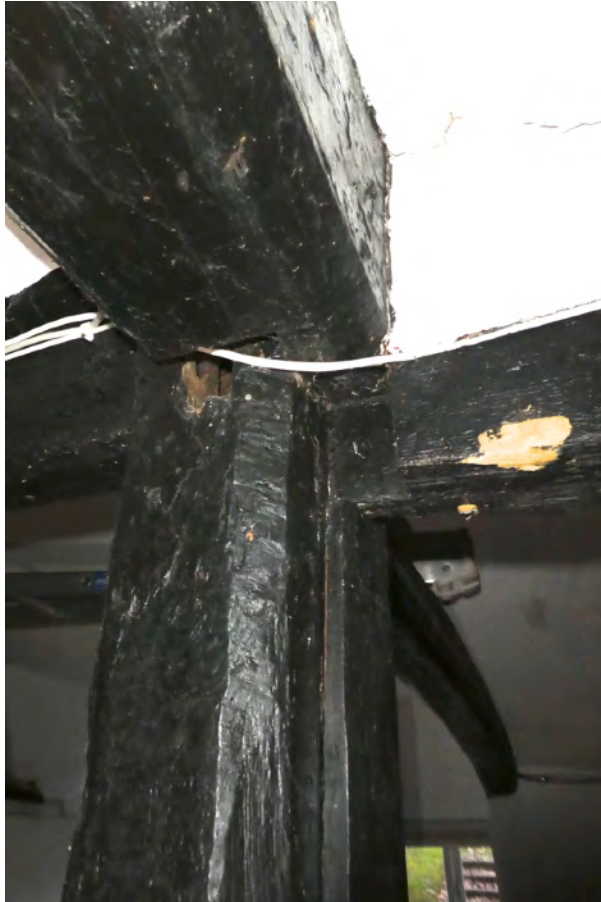
7. Phase 1 west end rear post from inside phase 1 kitchen showing mortise for removed cross beam beneath phase 2 inserted lapped cross beam. Leanto beyond.

The replacement floor in the western kitchen is of crossbeam construction having a chamfered crossbeam measuring 160mm wide x 150mm (15). This is lapped to the Phase 1 rear post where there is a cut off tenon for the previous crossbeam of the end of the two storey Phase 1 bay (7). The joists span along the length of the building and are 80mm x 80mm square matching the size of the Phase 1 and possibly reusing material.

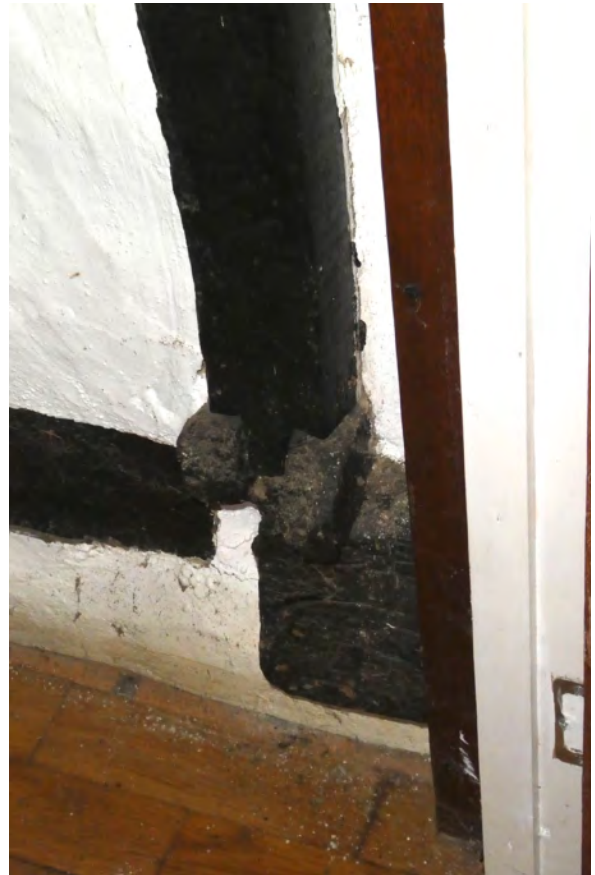
8. End of phase 1 west leanto plinth plate from the rear leanto looking north.

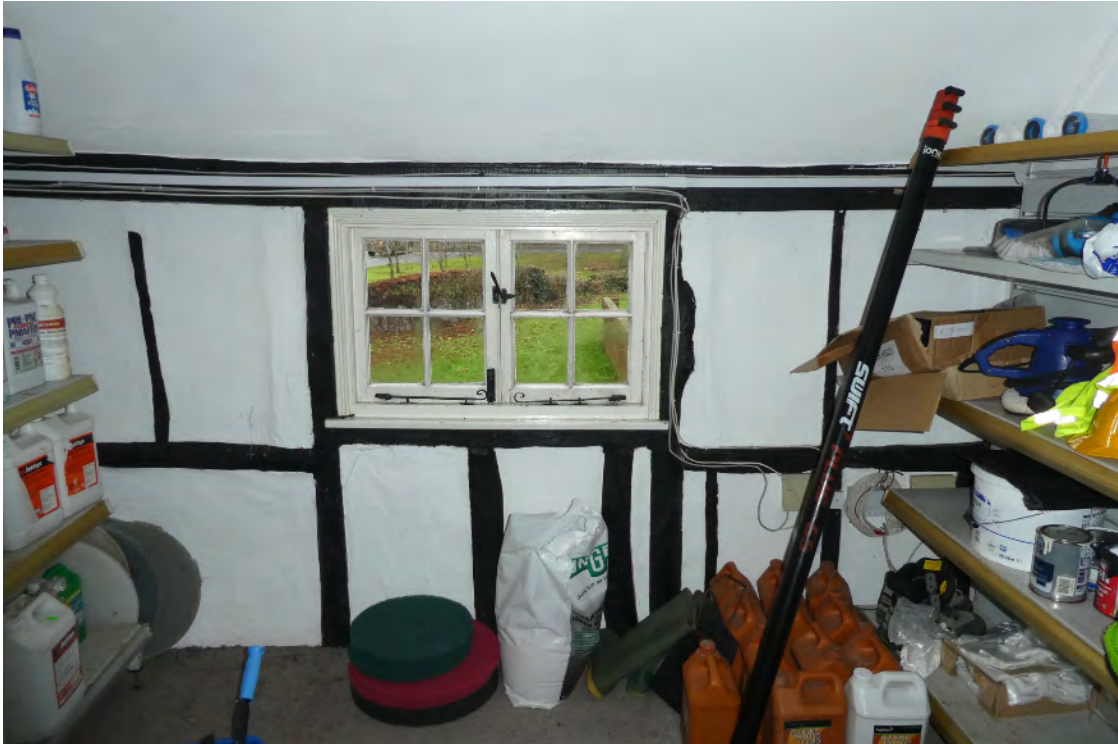
9. Inside front wall of phase 1 services first floor chamber showing slender small square panel framing with interrupted midrails with raised cill for window in original position.

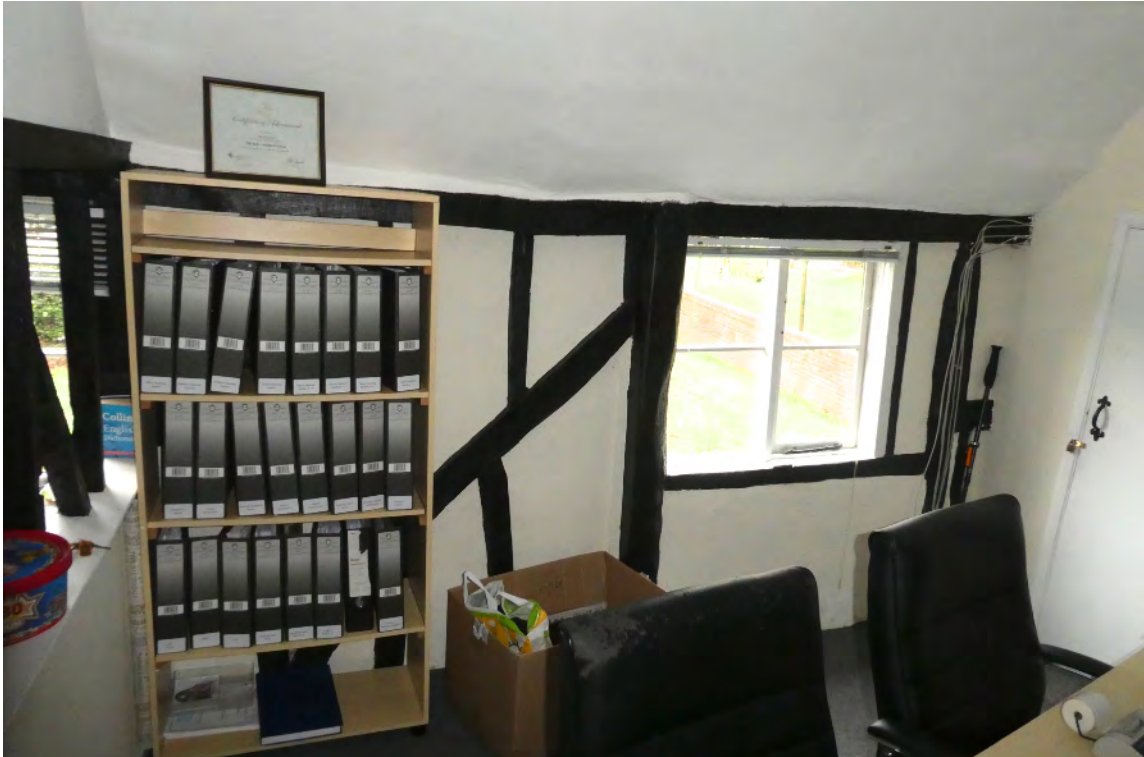
10. Inside of front wall showing front west post of phase 1 main frame centre with phase 1 small square panel right and raised cill for former window beyond stud. Phase 2 stud and raking strut construction left.

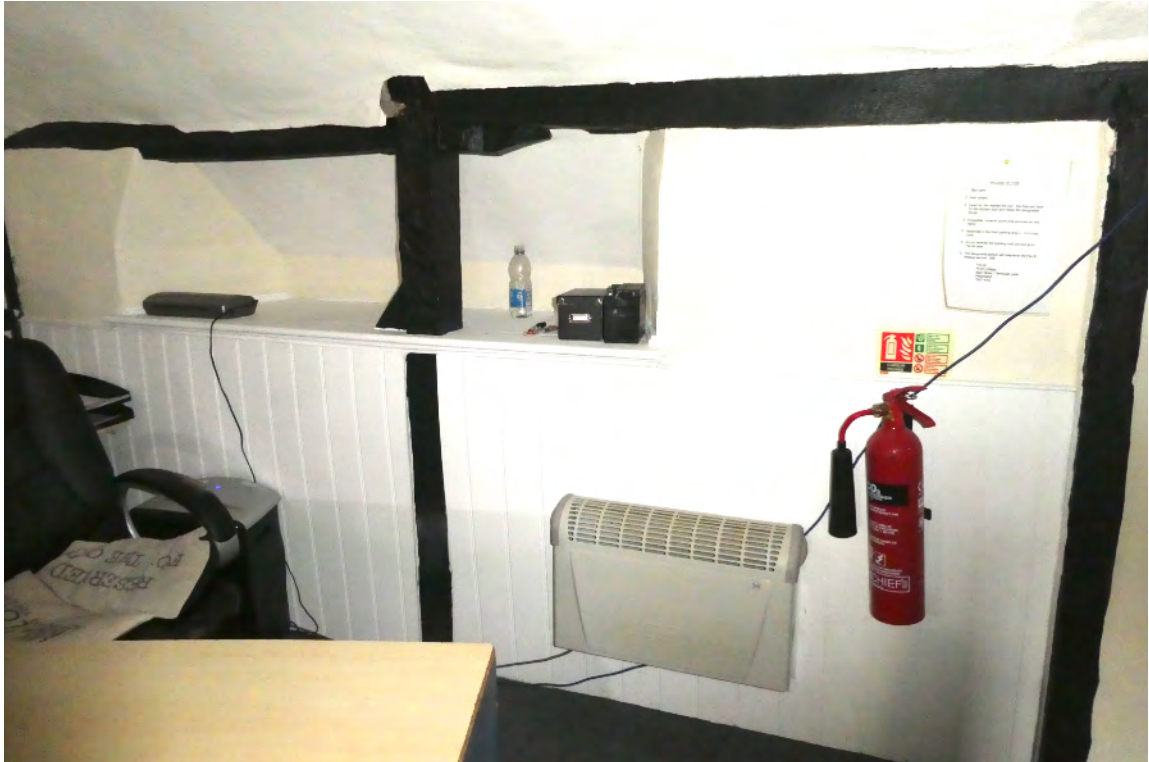
11. Inside rear wall of main frame at first floor showing phase 1 rear west post of main frame centre left with main eaves plate over. Phase 2 eaves plate lapped over right.

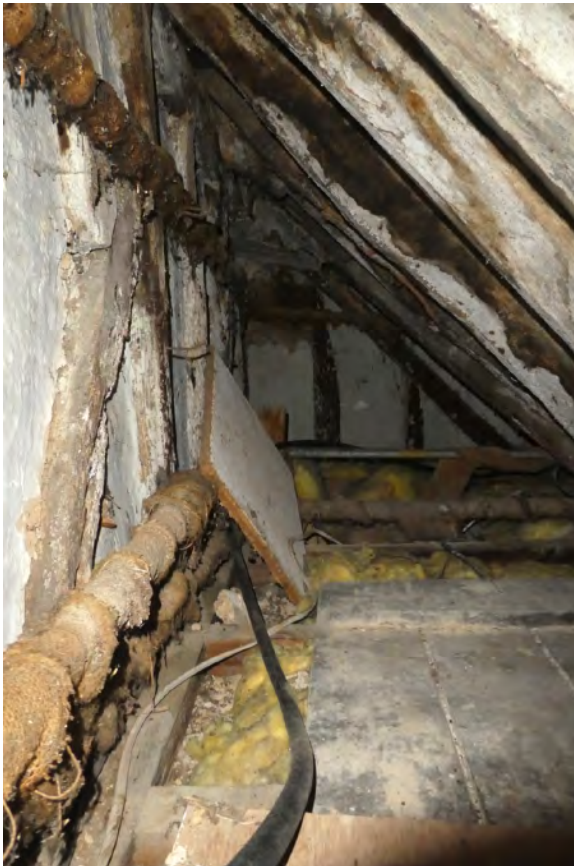
12. Leanto roof space to rear of phase 1 main frame of first floor services chamber looking east showing exposed studs and raking strut. Plaster set on chamber face (ie not an external wall).

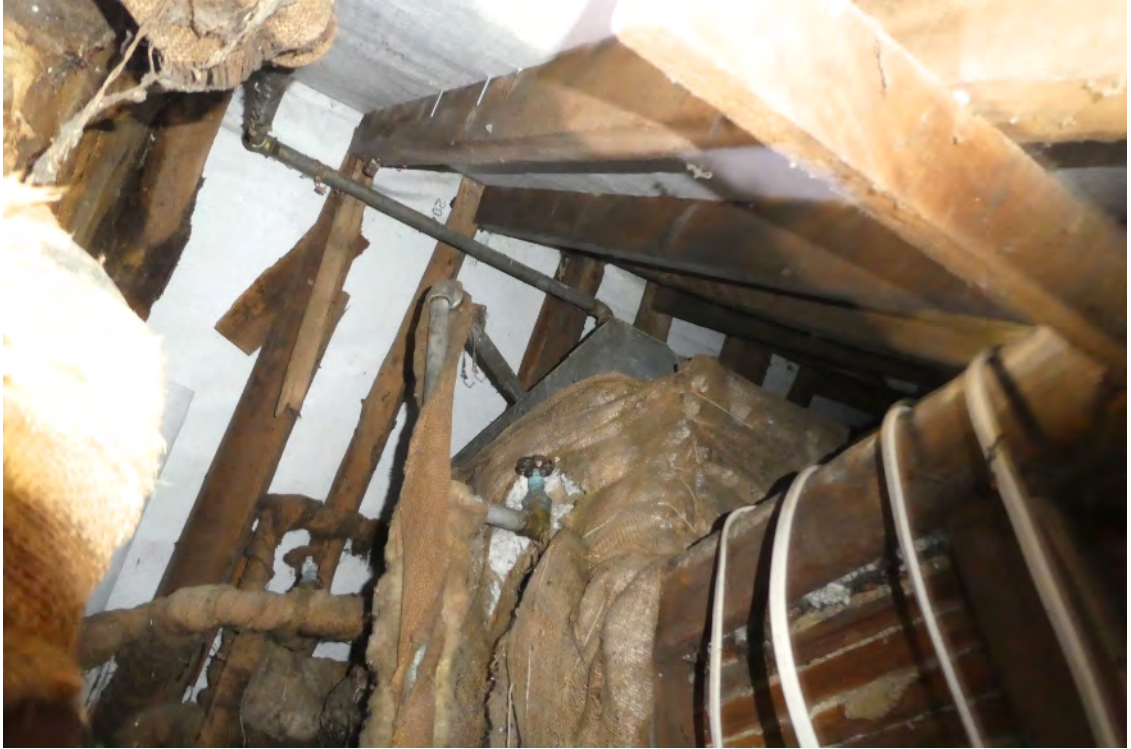
13. Phase 1 roof looking east showing paired rafter construction (lacking a ridge board), inserted chimney left, later inserted partition adjoining a lowered ceiling bottom right.

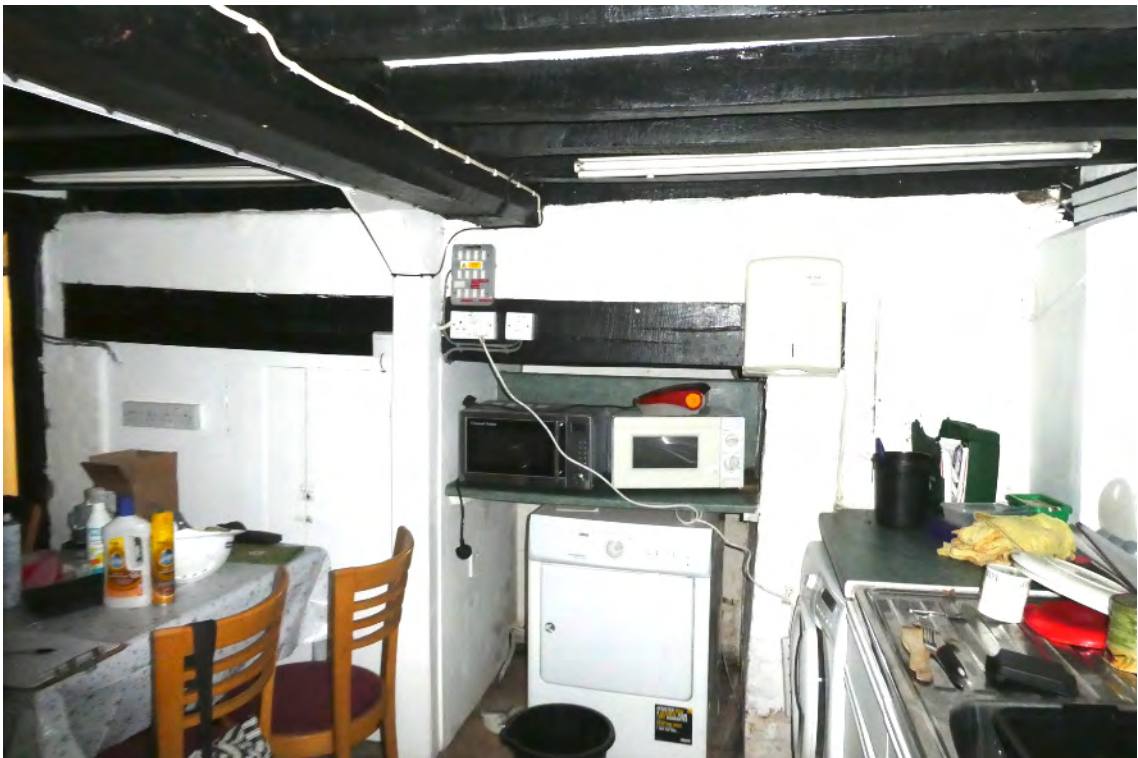
14. Phase 2 east cottage kitchen (service room in phase 1 building) looking west showing inserted phase 2 inglenook fireplace, phase 1 girder ceiling top.

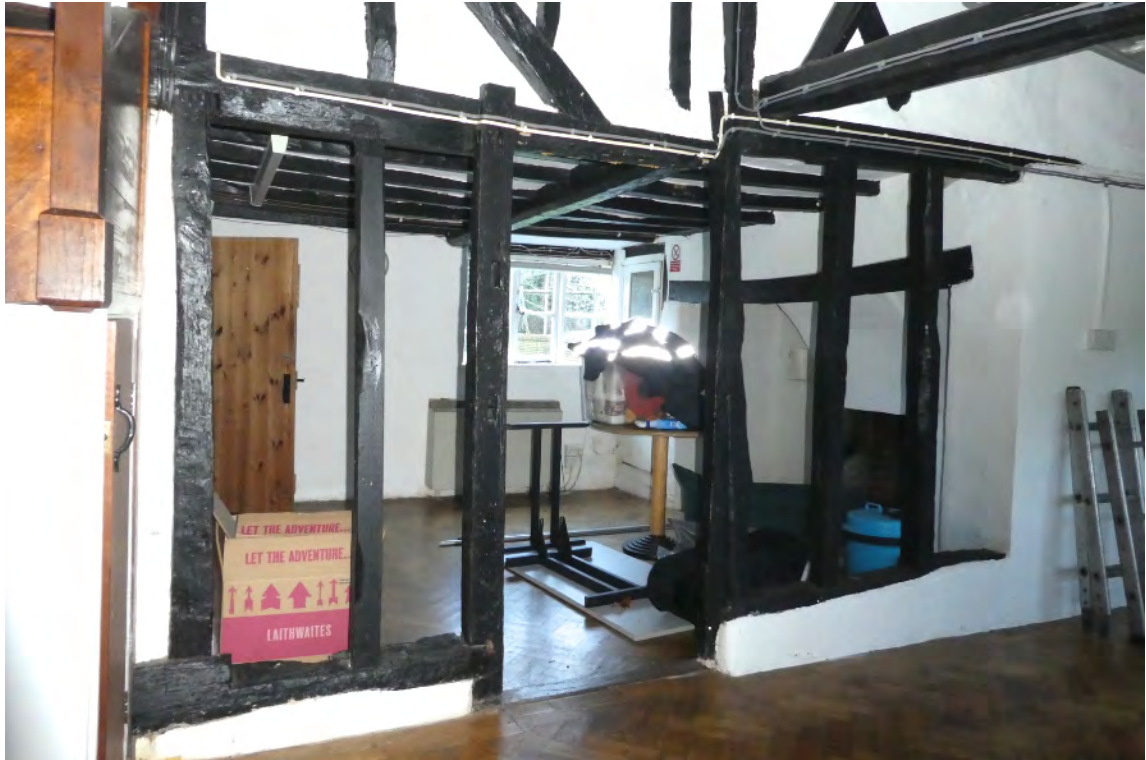
15. Rear leanto looking north east towards front showing phase 2 west cottage kitchen and inserted inglenook fireplace. Phase 2 replacement first floor construction over.

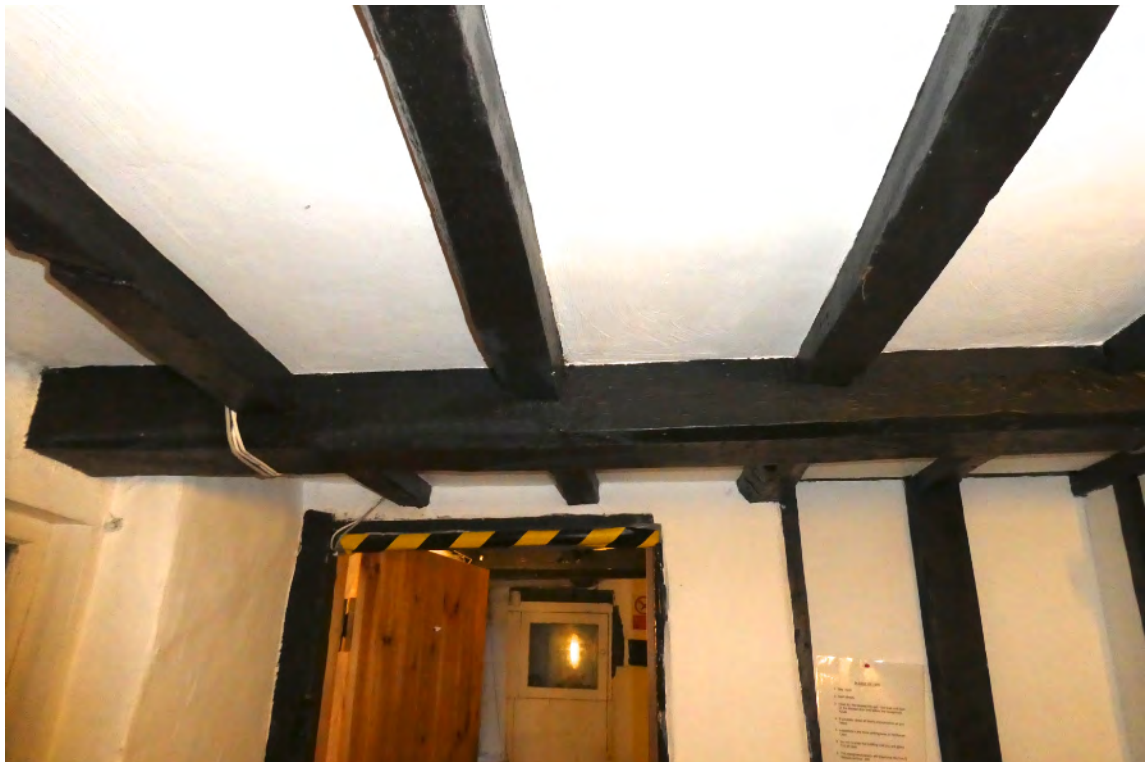
16. First floor cross beam and joists over phase 2 west bay.

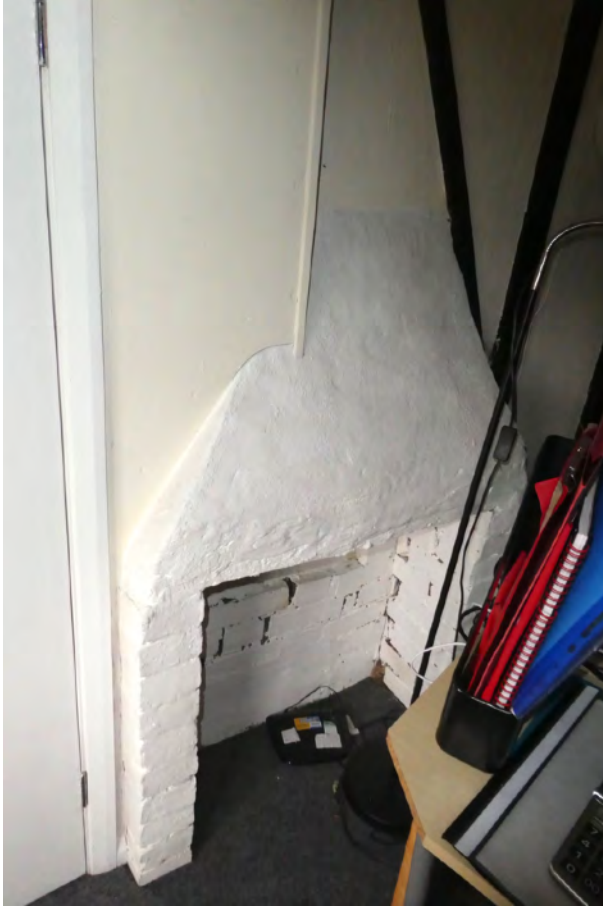
17. Phase 2 west cottage first floor fireplace.

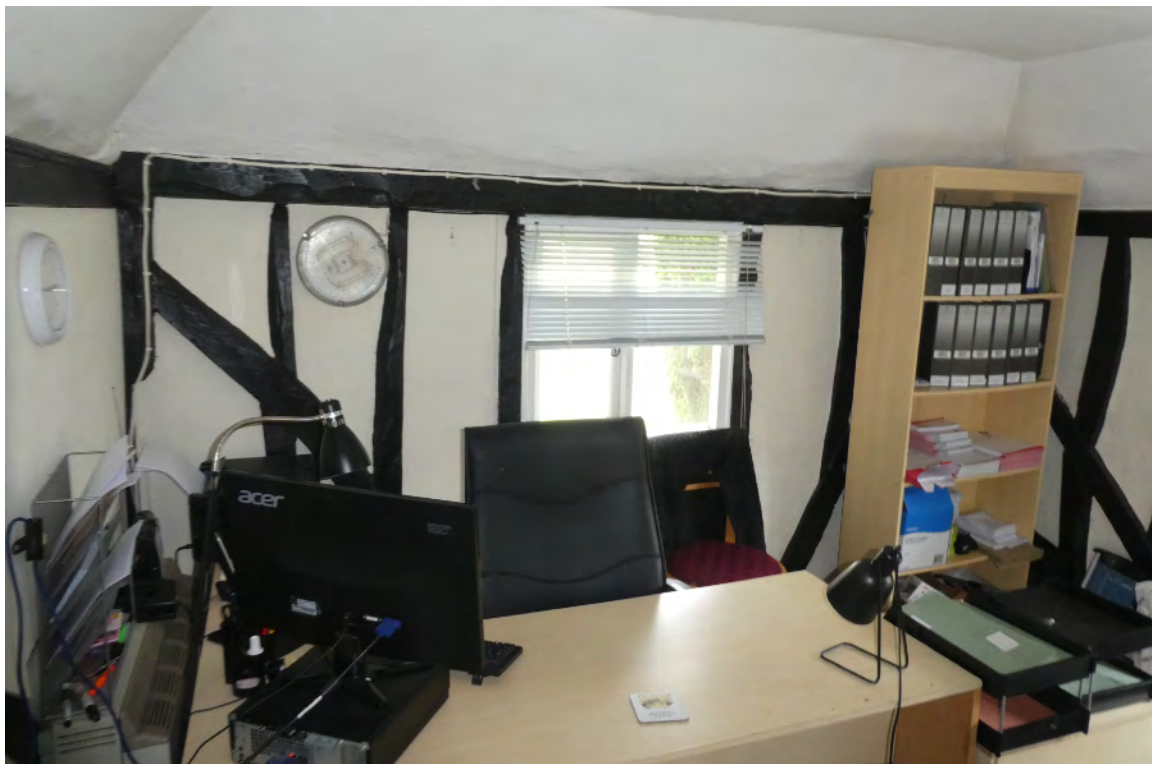
18. Phase 2 added west bay looking west in first floor chamber showing raking strut and stud construction and bowl shaped jowl to head of principal post left.

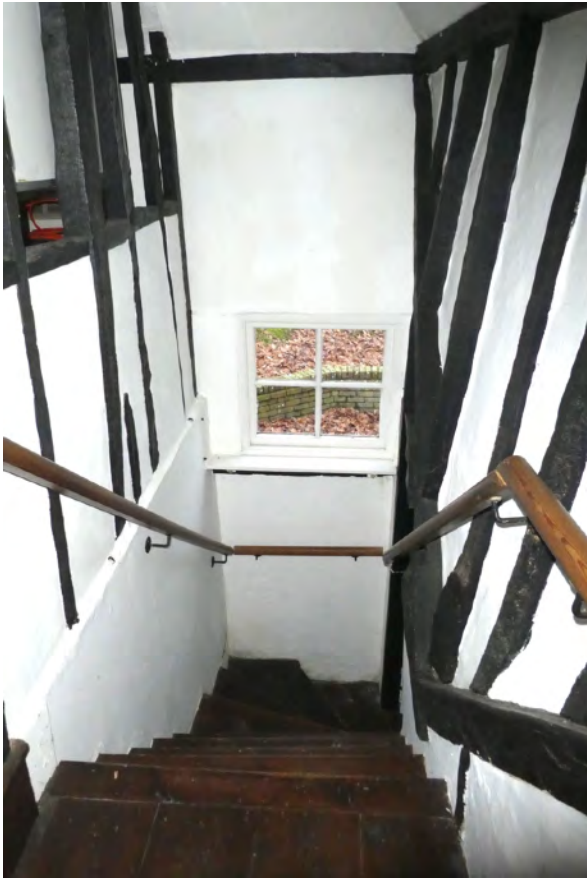
19. Phase 3 stairs looking to rear, main part of phase 3 extension left, return leanto right.

At some stage the stairs to the western cottage were replaced in the opposite direction and a new doorway formed into the main accommodation.

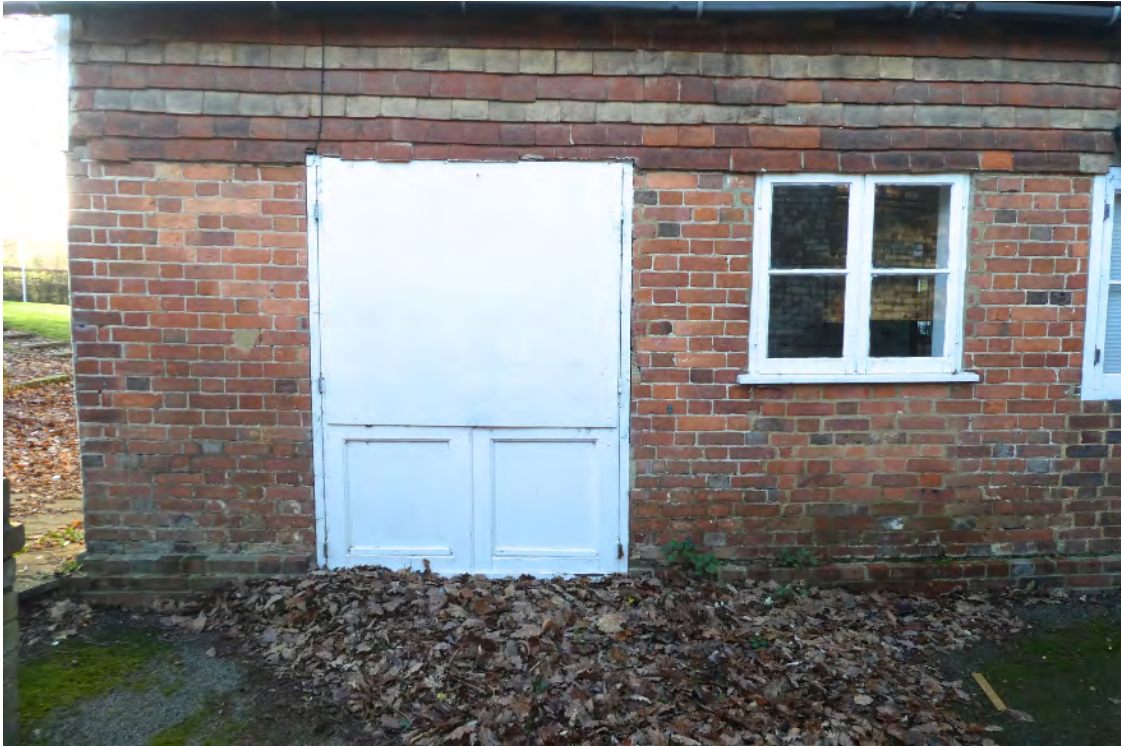
3. Former cafe entrance doors at east end proposed to be reinstated as French doors.

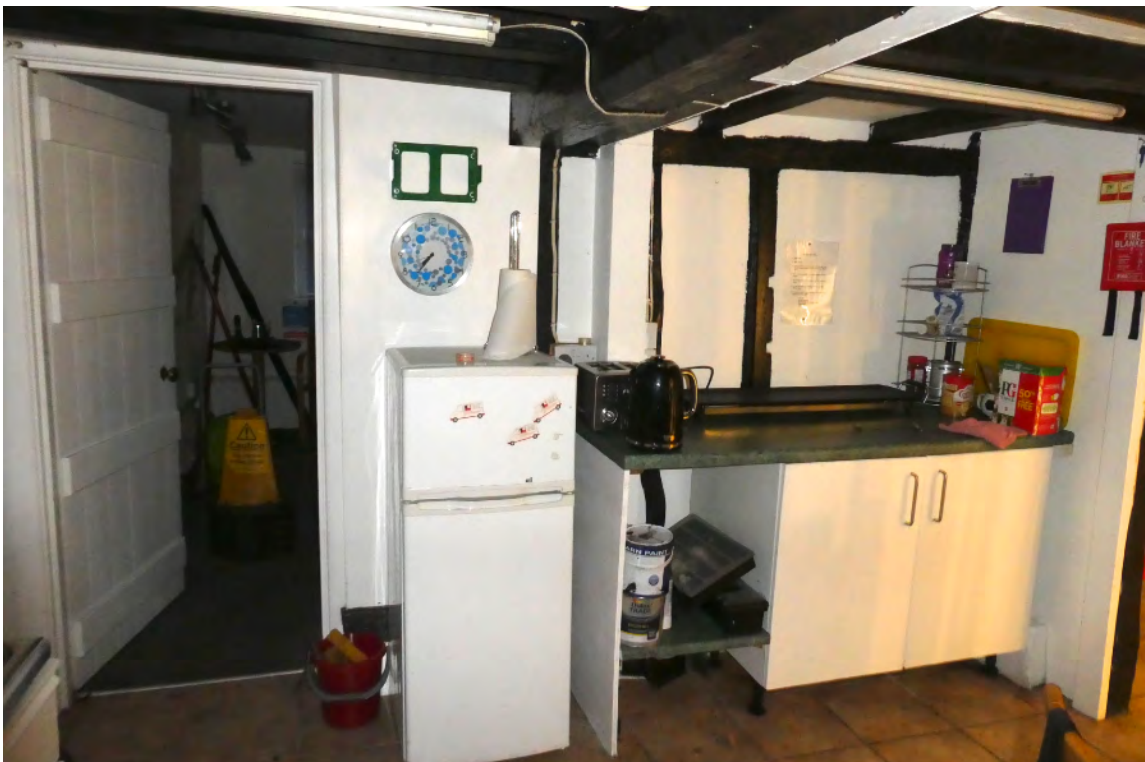
4. Internal door proposed to be blocked left.

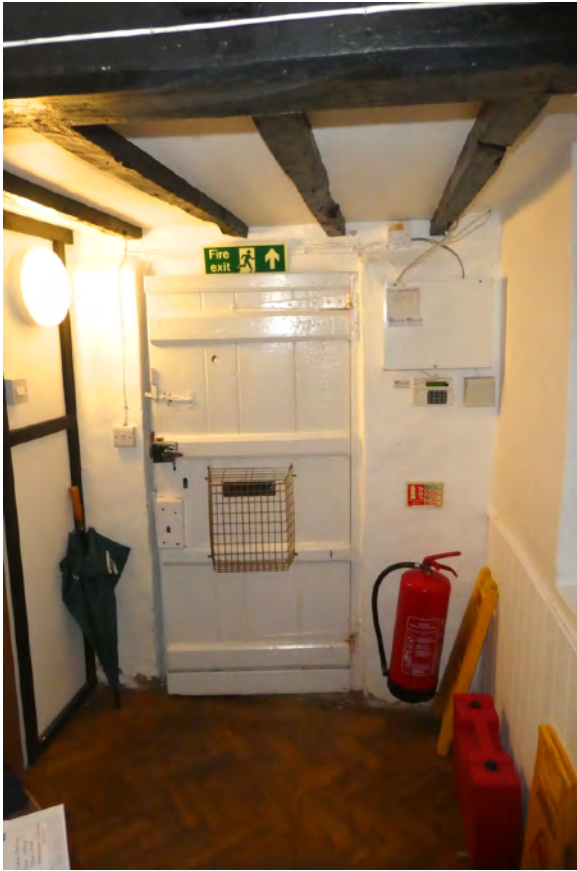
5. West side lobby. Floor proposed to be raised to be level with remainder of ground floor.

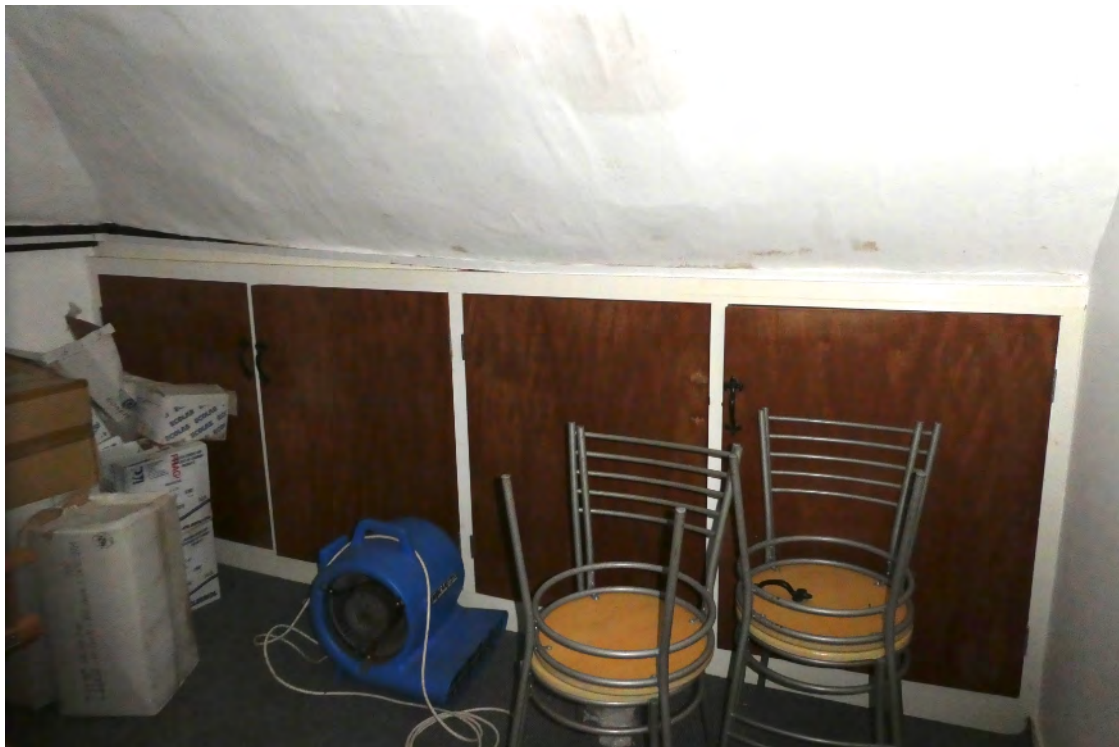
6. Cupboards and partition proposed to be removed at first floor east.
